JOHN & JENNIFER WHARTON : ARCHITECT DESIGNERS

STRUCTURAL STATEMENT
Maypole Barn
Main Street
LONG PRESTON

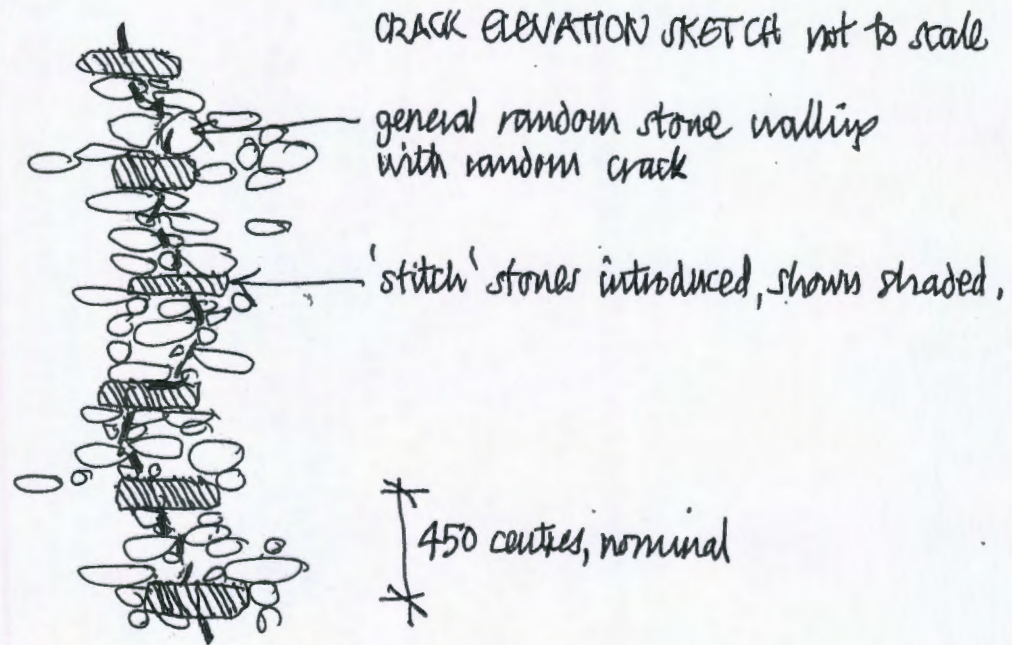
MASONRY CRACKS - INNER OR OUTER WALLS REPAIR METHOD

Random sandstone nominal 600mm thick with gritstone squared quoins, generally plumb, some lean to the plan step on the eastern side. Some settlement cracks to the north gable, east and west walls likely due to use of small random stone, lack of 'through' stones and vibration from heavy traffic on the A65.

Fault - settlement cracks caused by use of small stones + inadequate overlap, lack of 'through' stones in wall + lack of maintenance.

The cracks are capable of stitch repair as per the attached sketch and notes.

Repair - Insert new wider + flatter stones across the crack at nominal 450 centres vertically, one stone at a time, start at bottom. Repoint wall in lime/sand mortar, with dark grit inclusions
