# Your survey and valuation report

21 Napier Road, Swalwell,  
Newcastle upon Tyne, NE16 3BT

26th February 2026

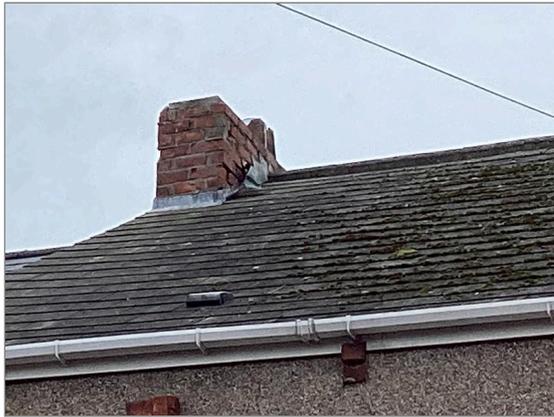
From ground level, the chimney appears to require a general programme of maintenance including repairs to the defective areas of mortar pointing. This should be carried out soon.

The lead flashing which provides waterproofing between the chimney stack and the roof covering has lifted and has come loose. This could lead to water ingress and should be repaired soon. We refer you to our later comments in E1 Roof Structure regarding staining to the chimney breast and roof timbers.

*Photo - 2 Defective flashings, repointing required*

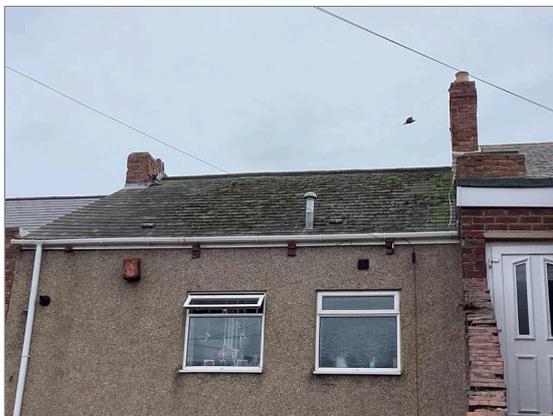
Moss growth is present on the roof slopes. This can impede the runoff of rainwater, lead to gutter blockages and cause water penetration, which in turn may lead to rot or other defects in nearby timbers. If moss is allowed to accumulate, it will retain damaging moisture on the surface, leading to deterioration of the covering. It would be prudent for all moss growth to be brushed away from the roof. It is likely that once the moss is removed repairs could be required to the roof coverings, or repointing may be necessary to the ridge or hip tiles.

Photo - 3 Rear roof moss, asbestos tiles

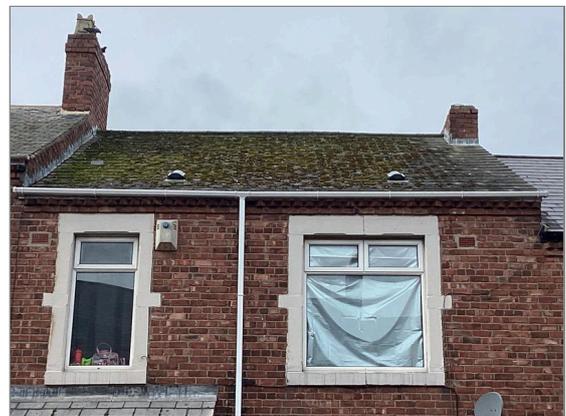
Photo - 4 Front roof moss, asbestos tiles

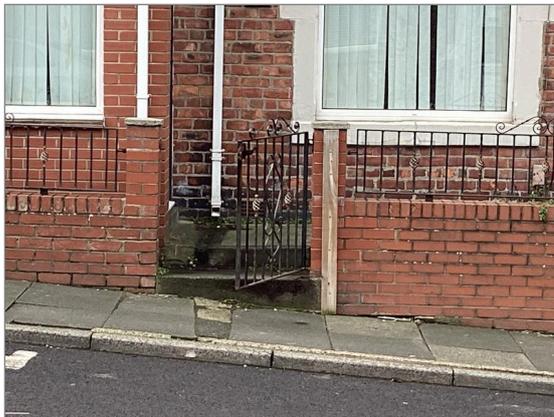
The rainwater pipe to the front elevation discharges directly onto the pavement which is not ideal because it may lead to ice covered pavements in winter. It is important to keep this channel free flowing and ensure the rainwater pipes feed into it efficiently.

*Photo - 5 Front downpipe discharges to ground and on to pavement*

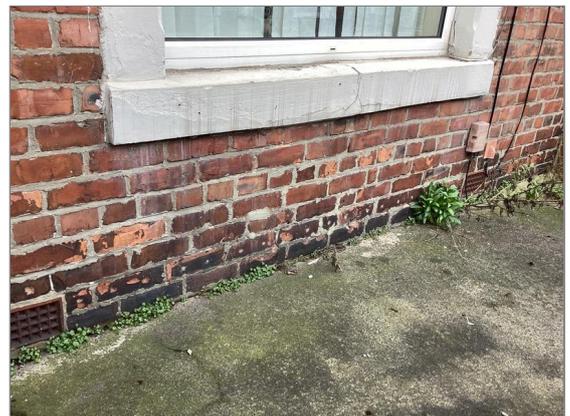
A remedial damp proof course has been installed, indicating the original DPC (if any) has failed at some point in the past. You should be aware that remedial DPCs are often not reliable and further works may be required. Your Legal Adviser should confirm the existence and validity of any guarantees for:

Photo - 7 Remedial dpc

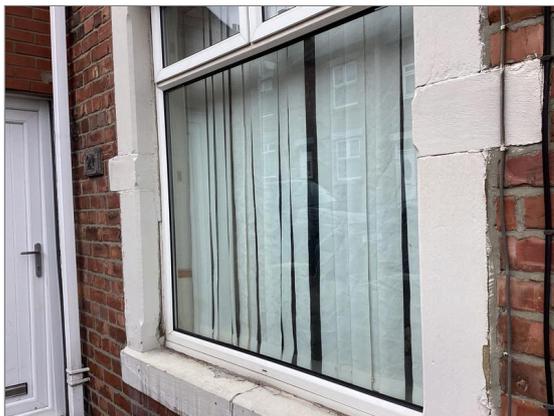
The glazing to the front living room does not appear to comprise safety glass and there are obvious safety and security implications. We strongly urge you to replace the glass with toughened safety glass carrying the BS Kitemark. This is a risk to people:

*Photo - 8 Low window front living room no safety glass*

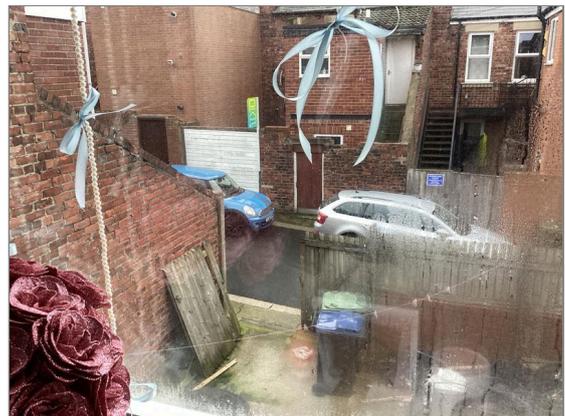
Double-glazing has a limited life and is prone to deterioration at edge seals. Some units appear to have failed, for example in two of the bedrooms and the bathroom, and renewal of the glazing is now necessary. Inevitably, other panels of a similar age may require renewal in the near future too and enquiries in respect of any available guarantees would be prudent. The quality of double-glazed units can vary. Whilst the remaining units in the property appear sound at present, no comments can be made about long term durability.

*Photo - 9 Misted unit rear bedroom*

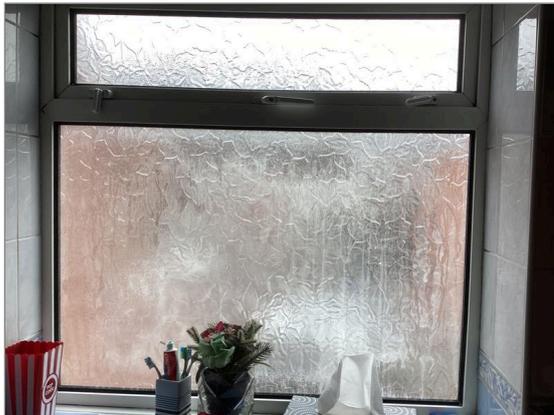
Photo - 10 Misted unit bathroom

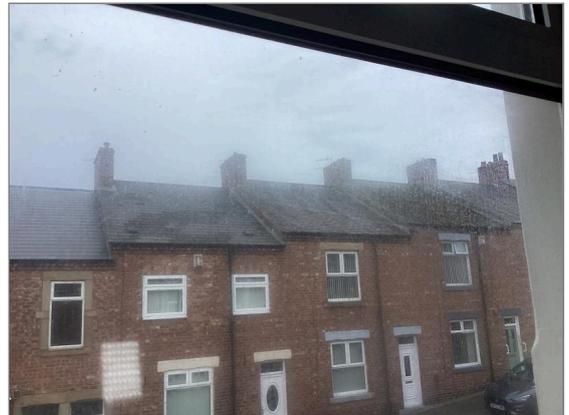
Photo - 11 Misted unit front small bedroom

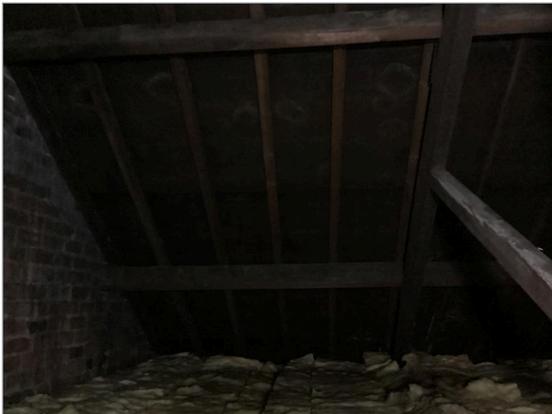
*Photo - 12 Signs of condensation*

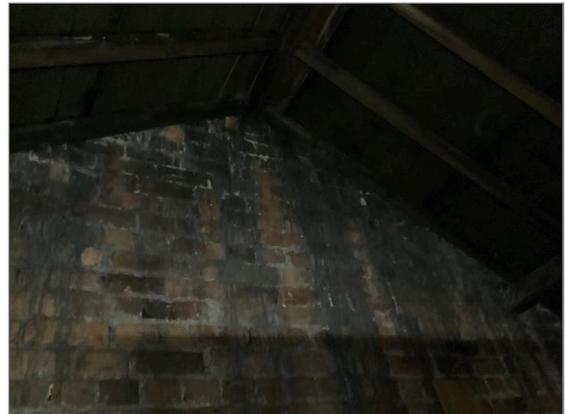
*Photo - 13 Staining, unable to test for damp*

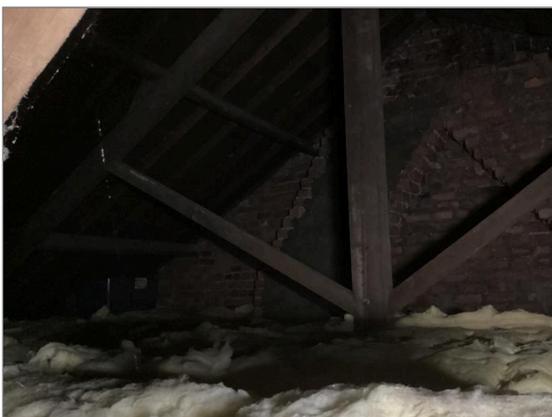
There is a redundant water tank and associated pipework in the roof space and you may consider it prudent to have this removed.

*Photo - 14 Redundant tank in loft*

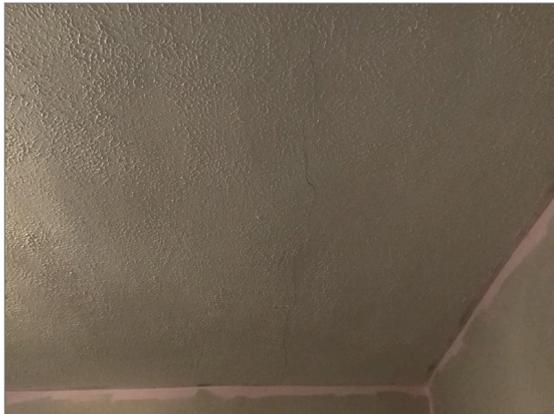
A textured decorative coating often referred to as 'Artex' covers the ceilings and this is deteriorating in places, for example in the bedrooms. This coating may contain small amounts of asbestos fibres which if disturbed or damaged, as is the case here, is a safety hazard. Specialist laboratory testing of samples would be needed to confirm if it was definitely present. You must seek advice from a licensed asbestos contractor prior to commencing works. We refer you to our later comments under Section E9 regarding the dangers and removal of asbestos. (Please see also Section I - Risks)

*Photo - 15 Crack to textured ceiling in rear bed ceiling*

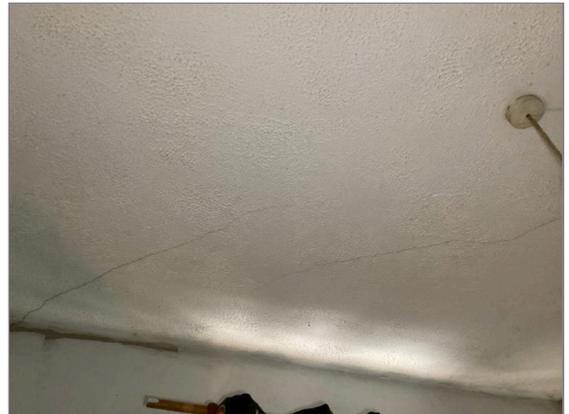
*Photo - 16 Cracks to textured ceiling in front small bed*

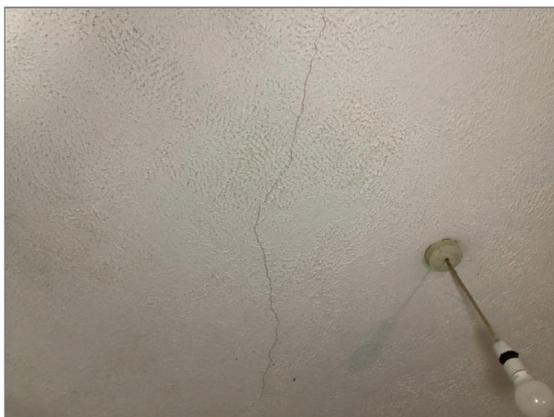
*Photo - 17 Crack to textured ceiling in front small bed*

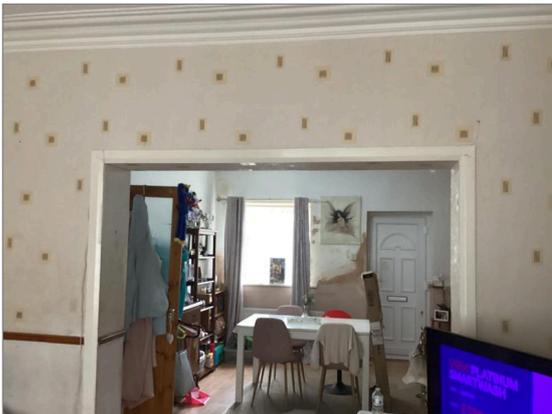
*Photo - 18 Wall removed*

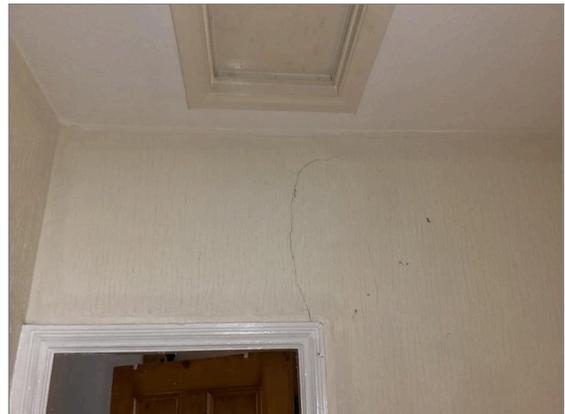
*Photo - 19 Cracked textured wall on landing*

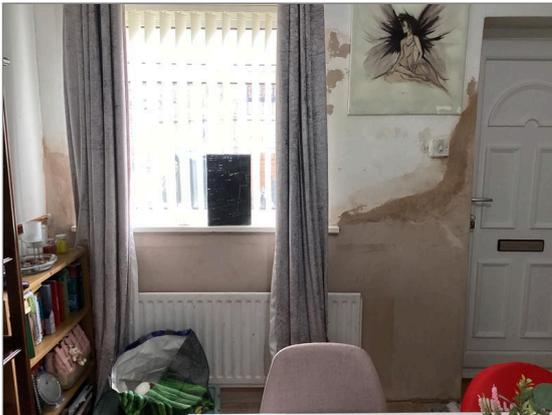
There were areas of bare plaster where we understand damp proofing work has been undertaken.

*Photo - 20 Damp proofing works*

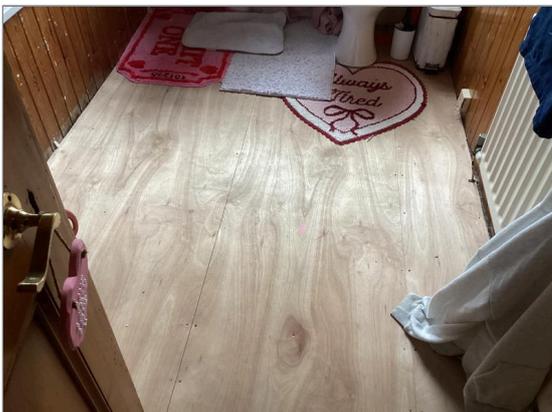
*Photo - 21 No floor covering in bathroom*

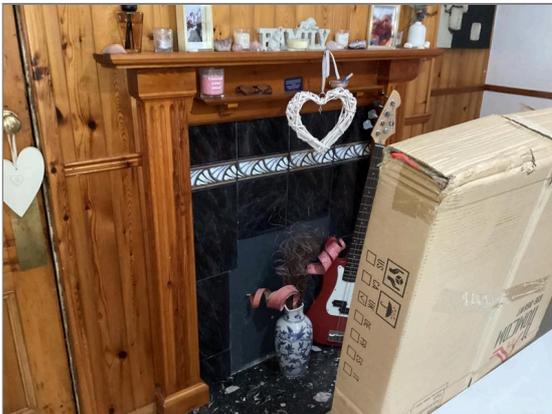
Photo - 22 Closed up fireplace in rear living room

If you wish to open up and reinstate the fireplaces which have been blocked up previously, you should be aware that the flues are likely to need relining to make them safe, and further works may also be required. You must obtain the advice of a HETAS registered contractor and have them carry out all recommended repairs before you use the fireplaces.

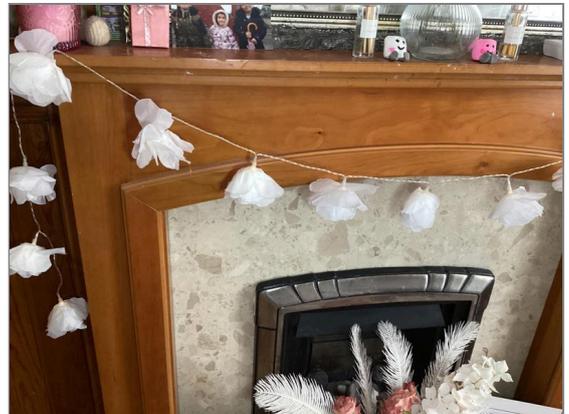
Photo - 23 Gas fire in front living room

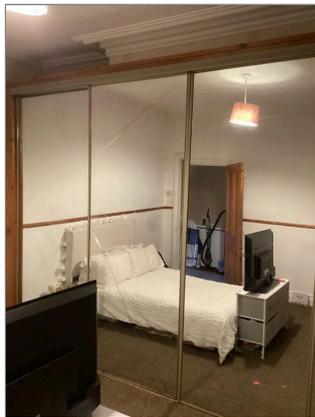
Photo - 24 Mirror glass broken in front bedroom

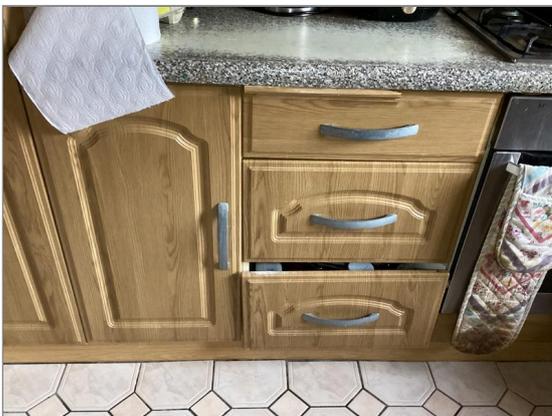
Photo - 26 Damaged drawers

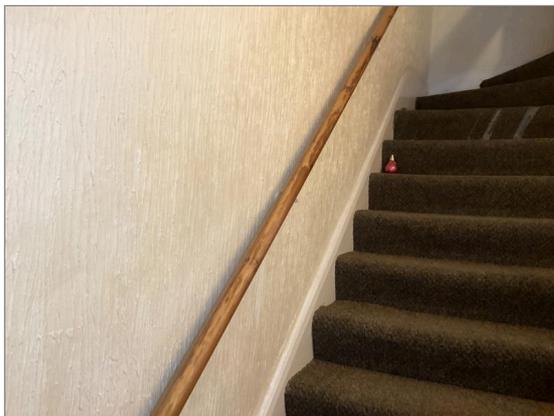
*Photo - 27 Loose handrail*

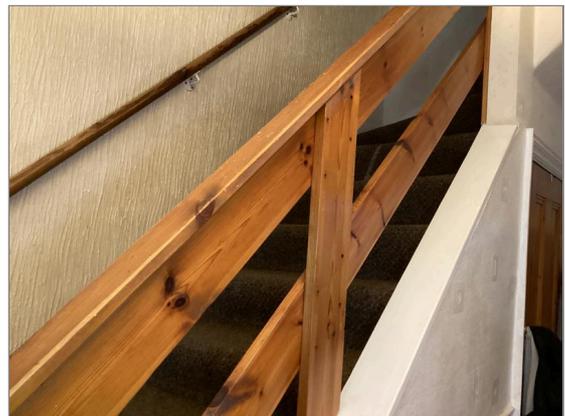
*Photo - 28 Large horizontal gaps*

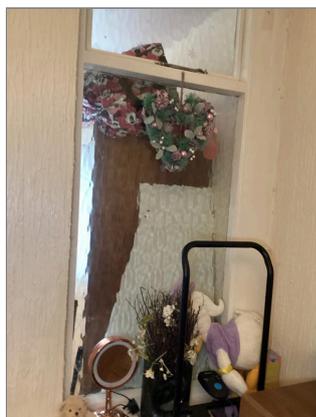
*Photo - 29 Internal window not safety glass*

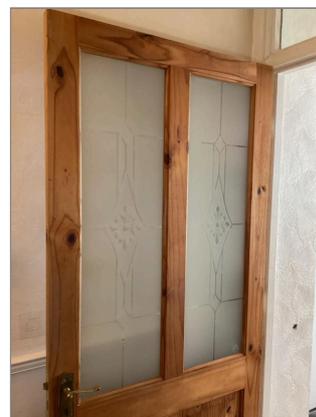
*Photo - 30 Internal door not safety glass*

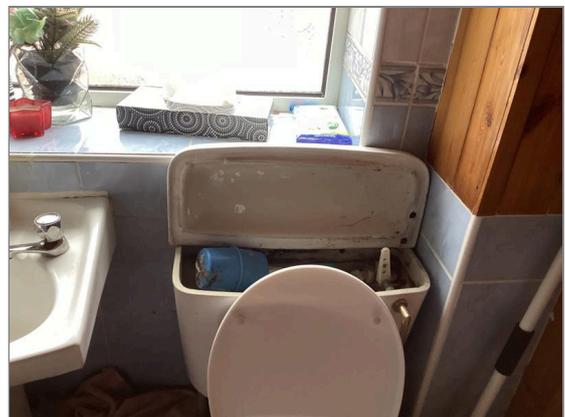
Photo - 32 Toilet not working properly

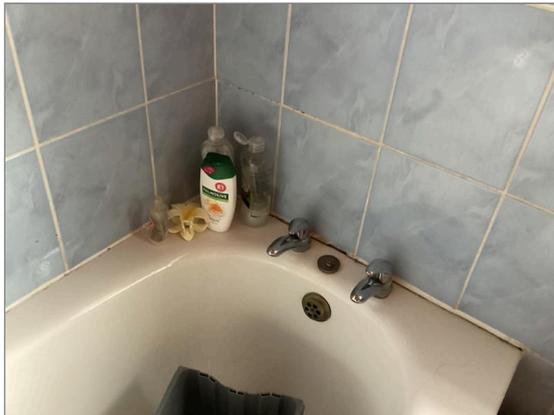
Photo - 33 Bath seals need attention

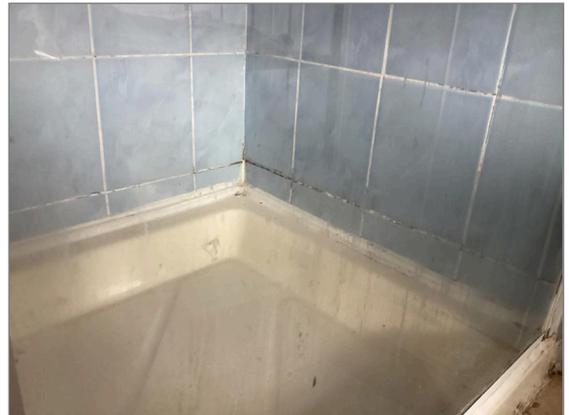
Photo - 34 Shower seals need attention

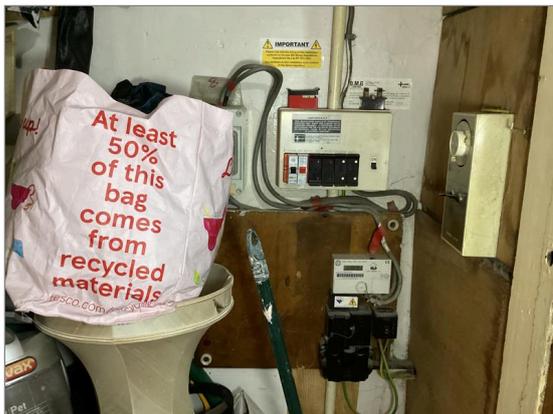
Photo - 35 Meter and consumer unit in cupboard in rear living room

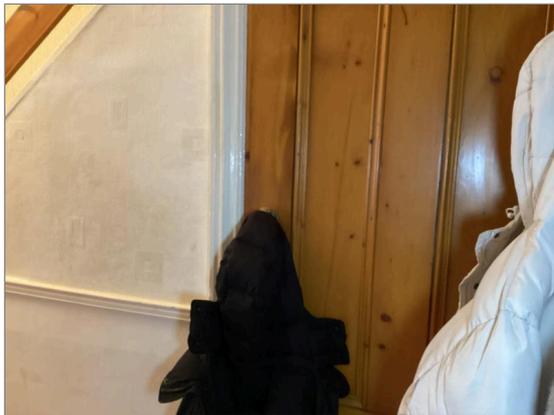
*Photo - 36 Gas meter in cupboard under the stairs, not seen*

The installation, including any gas appliances and flues, must be tested by a 'Gas Safe' registered contractor prior to exchange of contracts to confirm its safe operation and so that you are aware of any likely future costs. All recommendations should be implemented. Thereafter, the installation should be retested annually.

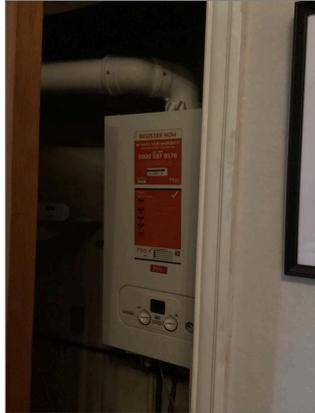
Where a gas appliance such as a boiler is located in a bedroom, the installation of mains operated

smoke and carbon monoxide detectors in that room is particularly important. In addition, the noise from a boiler may be nuisance at night.

Photo - 39 Gas central heating boiler in rear bedroom

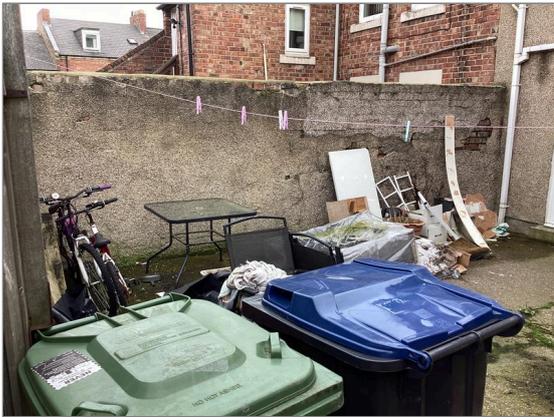
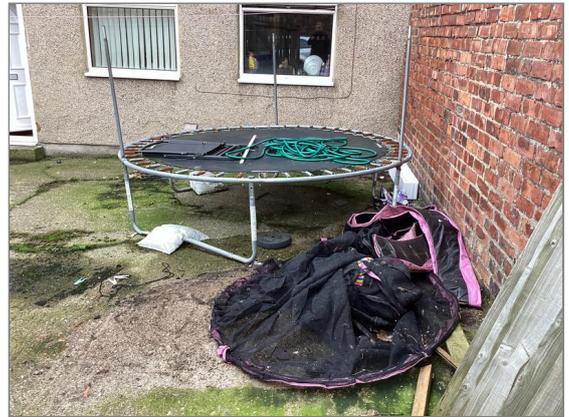
The yard is full of rubbish and stored items.

*Photo - 40 Rubbish, stored items*

*Photo - 41 Rubbish, stored items*

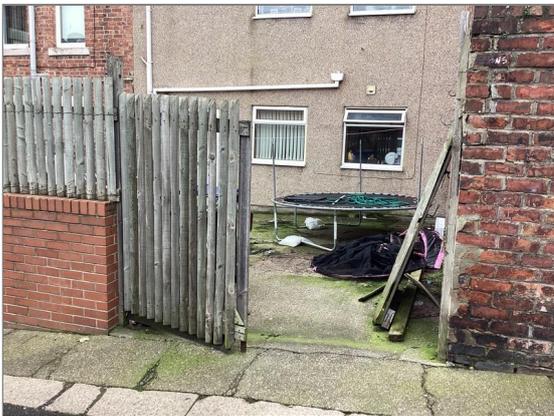
*Photo - 42 Broken gate*

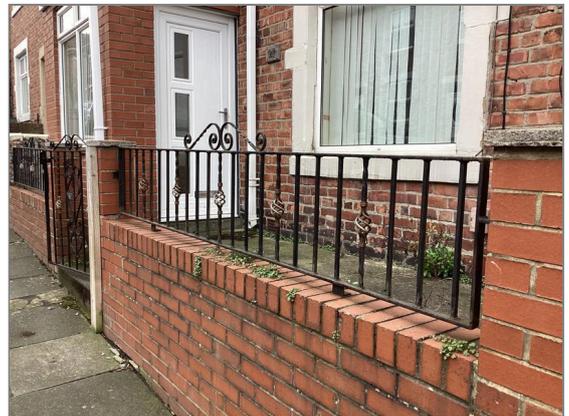
The railings are starting to loosen at the front of the property.

*Photo - 43 Railings starting to loosen*
