Proposed Residential Development
Land to the Rear of 25-35 Orchard Way
Harwell
Didcot
Oxfordshire
OX11 0LH

GEOTECHNICAL AND PHASE II CONTAMINATION REPORT

REPORT NO. 19058, July 2019

Client: Feltham Construction Limited

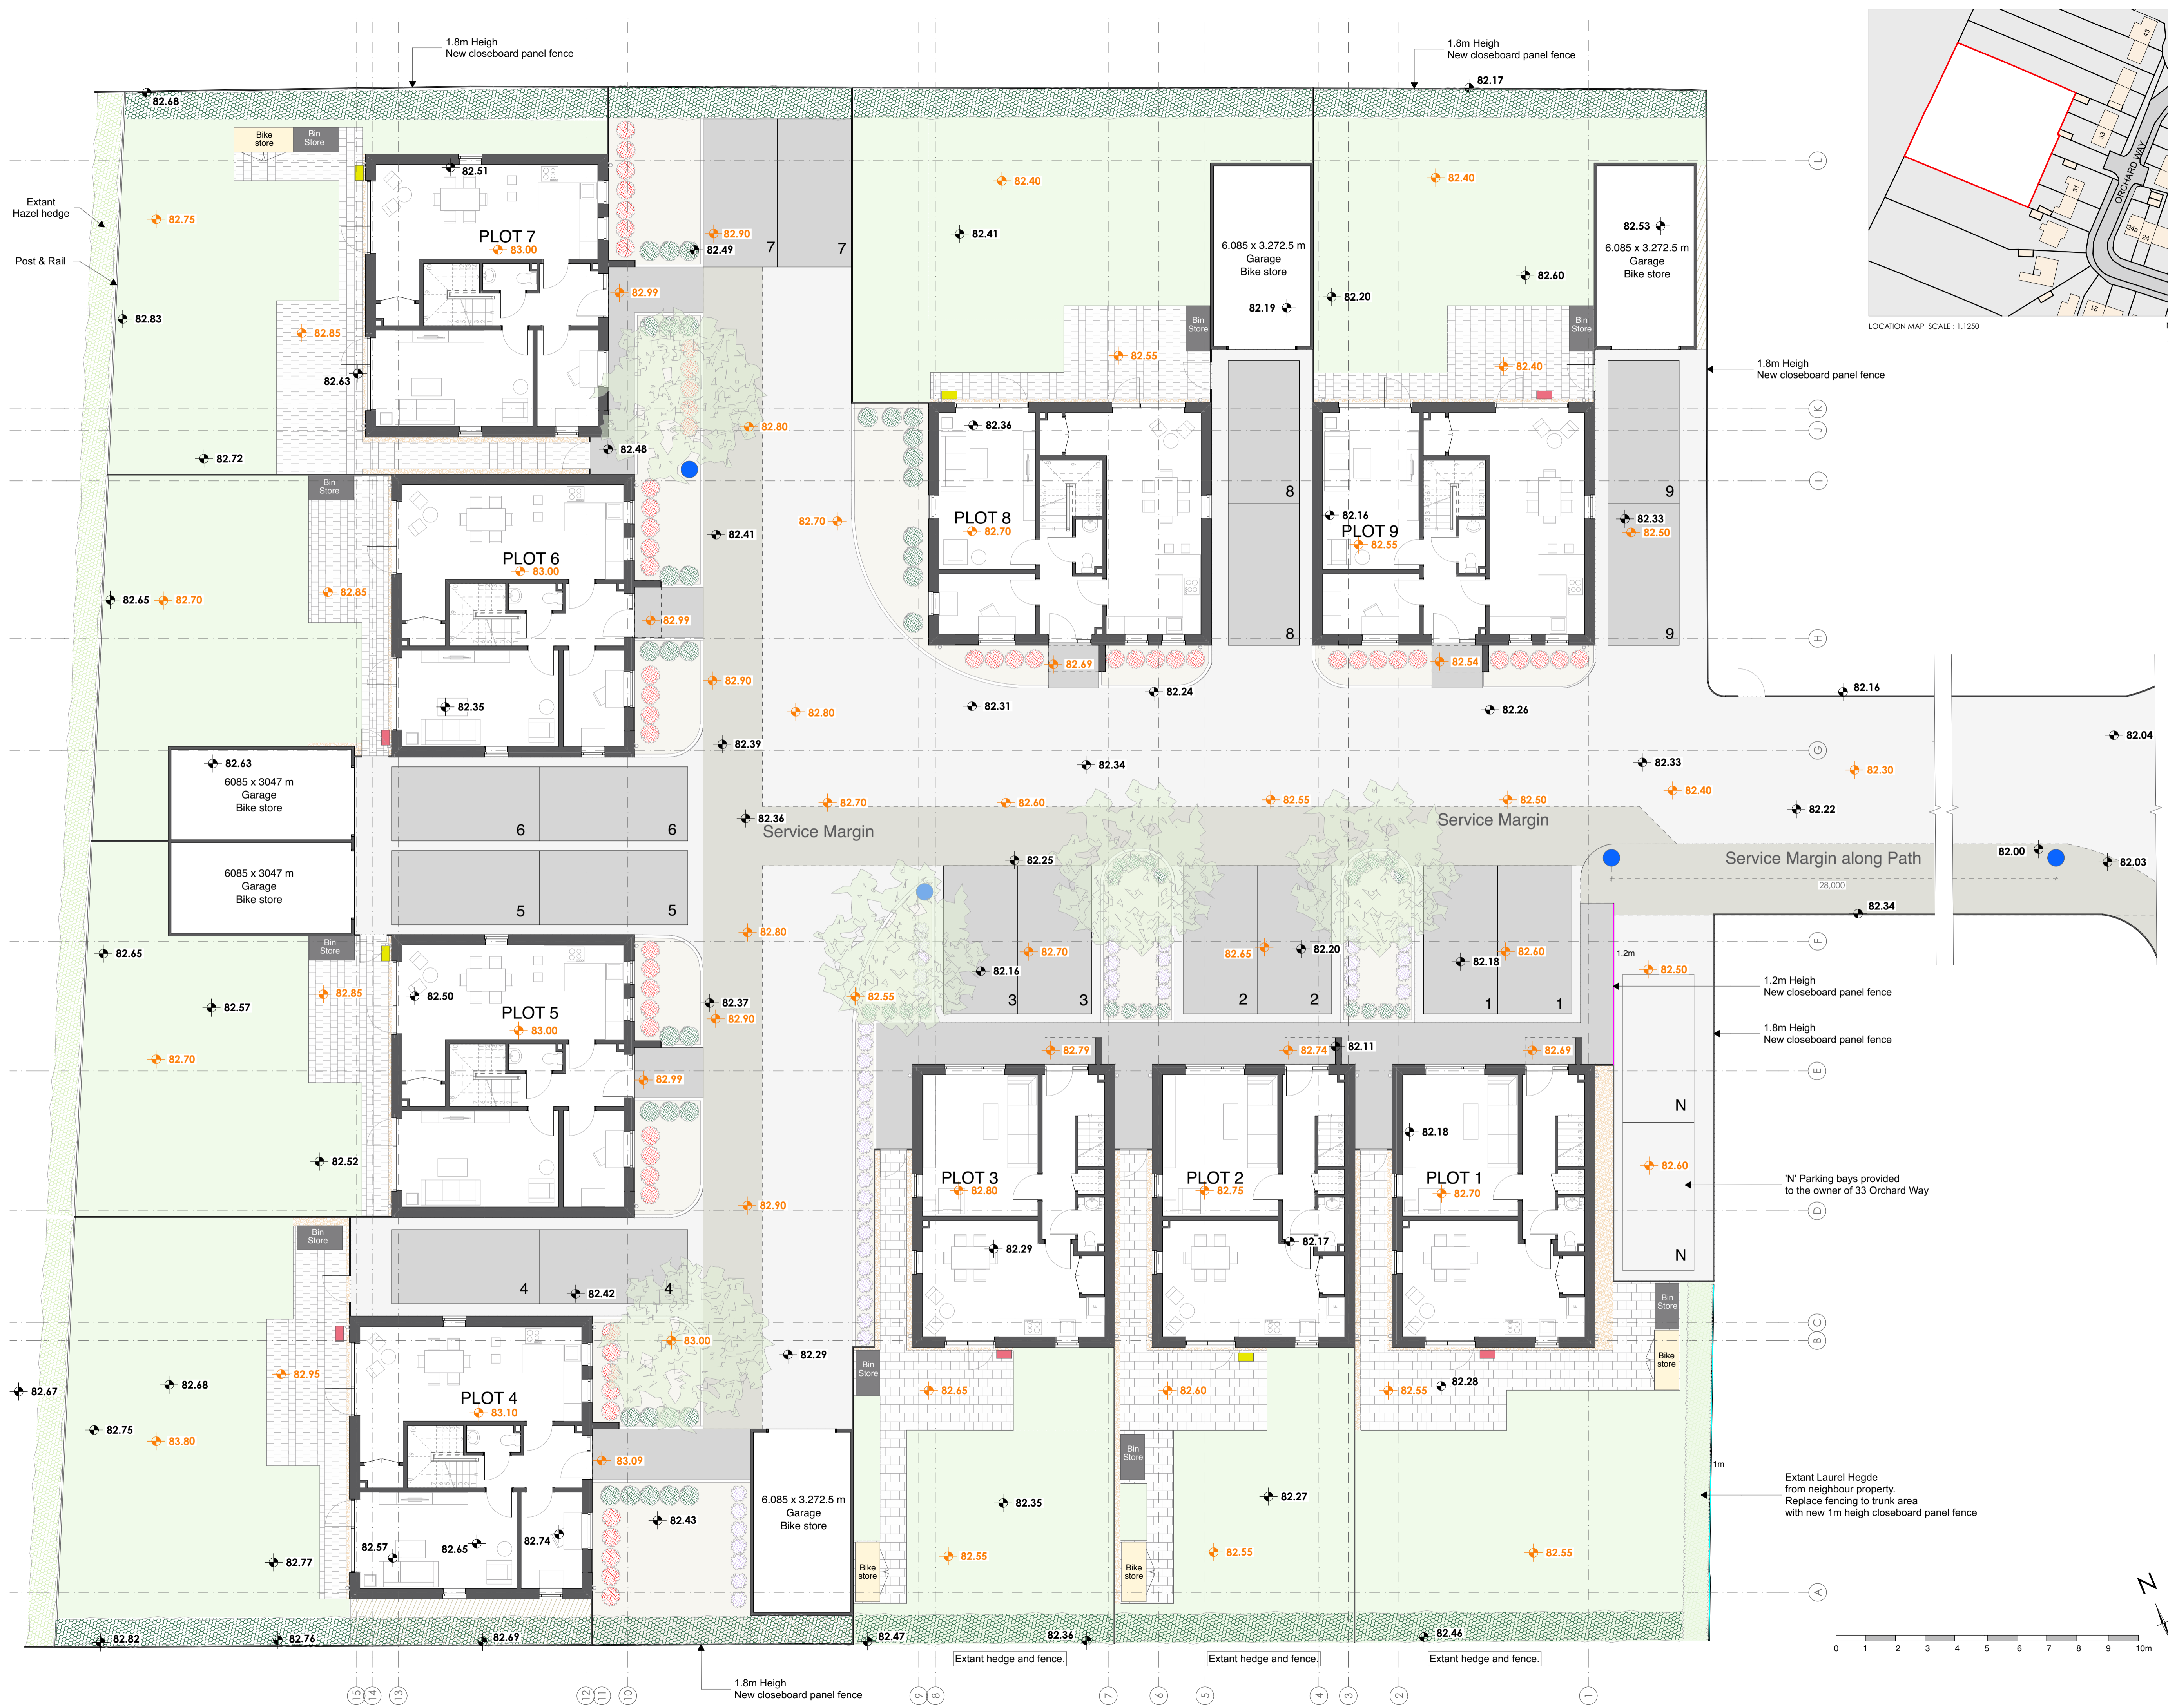
Status: **PRELIMINARY** Drawing Number: **FC906-H-100** Revision: **P3**

SOFT LANDSCAPE

- Plant types and species:
- Plant Type 1: Photinia x fraseri 'Little Red Robin'
 - Plant Type 2: Hebe Franciscana 'Blue Gem'
 - Plant Type 3: Viburnum Davidii
- Planting notes:
- Planting to housing side with horizontal wire hedging supports 400mm, 800mm, 4 plants per linear m.

Buildings	16 detached properties over two plots with garage/ bike storage.
Car Parking	2 No. car park spaces per property (32 No. in total).
Access Roads	Access roads to be built from Orchard Way.
Landscaping	Traditional private gardens.
Anticipated Foundations and Floor Slabs Shown on Preliminary Drawings	Currently unknown.
Building Level	Presumed at existing grade.

The proposed housing development will be constructed at, or close to, existing grade, locally on shallow (c.0.5m) upfilling. Intégrale understand that the development is to comprise sixteen 2-storey detached houses of load bearing masonry (and/or timber framed) construction with detached garages. Foundation line loads could be between 50 - 100kN/m run. Combined 'dead' and 'live' loading on the ground floor slabs will be less than 10kN/m². The development will also include new access roads, car parking, conventional gardens and perhaps limited, managed communal soft landscaping.

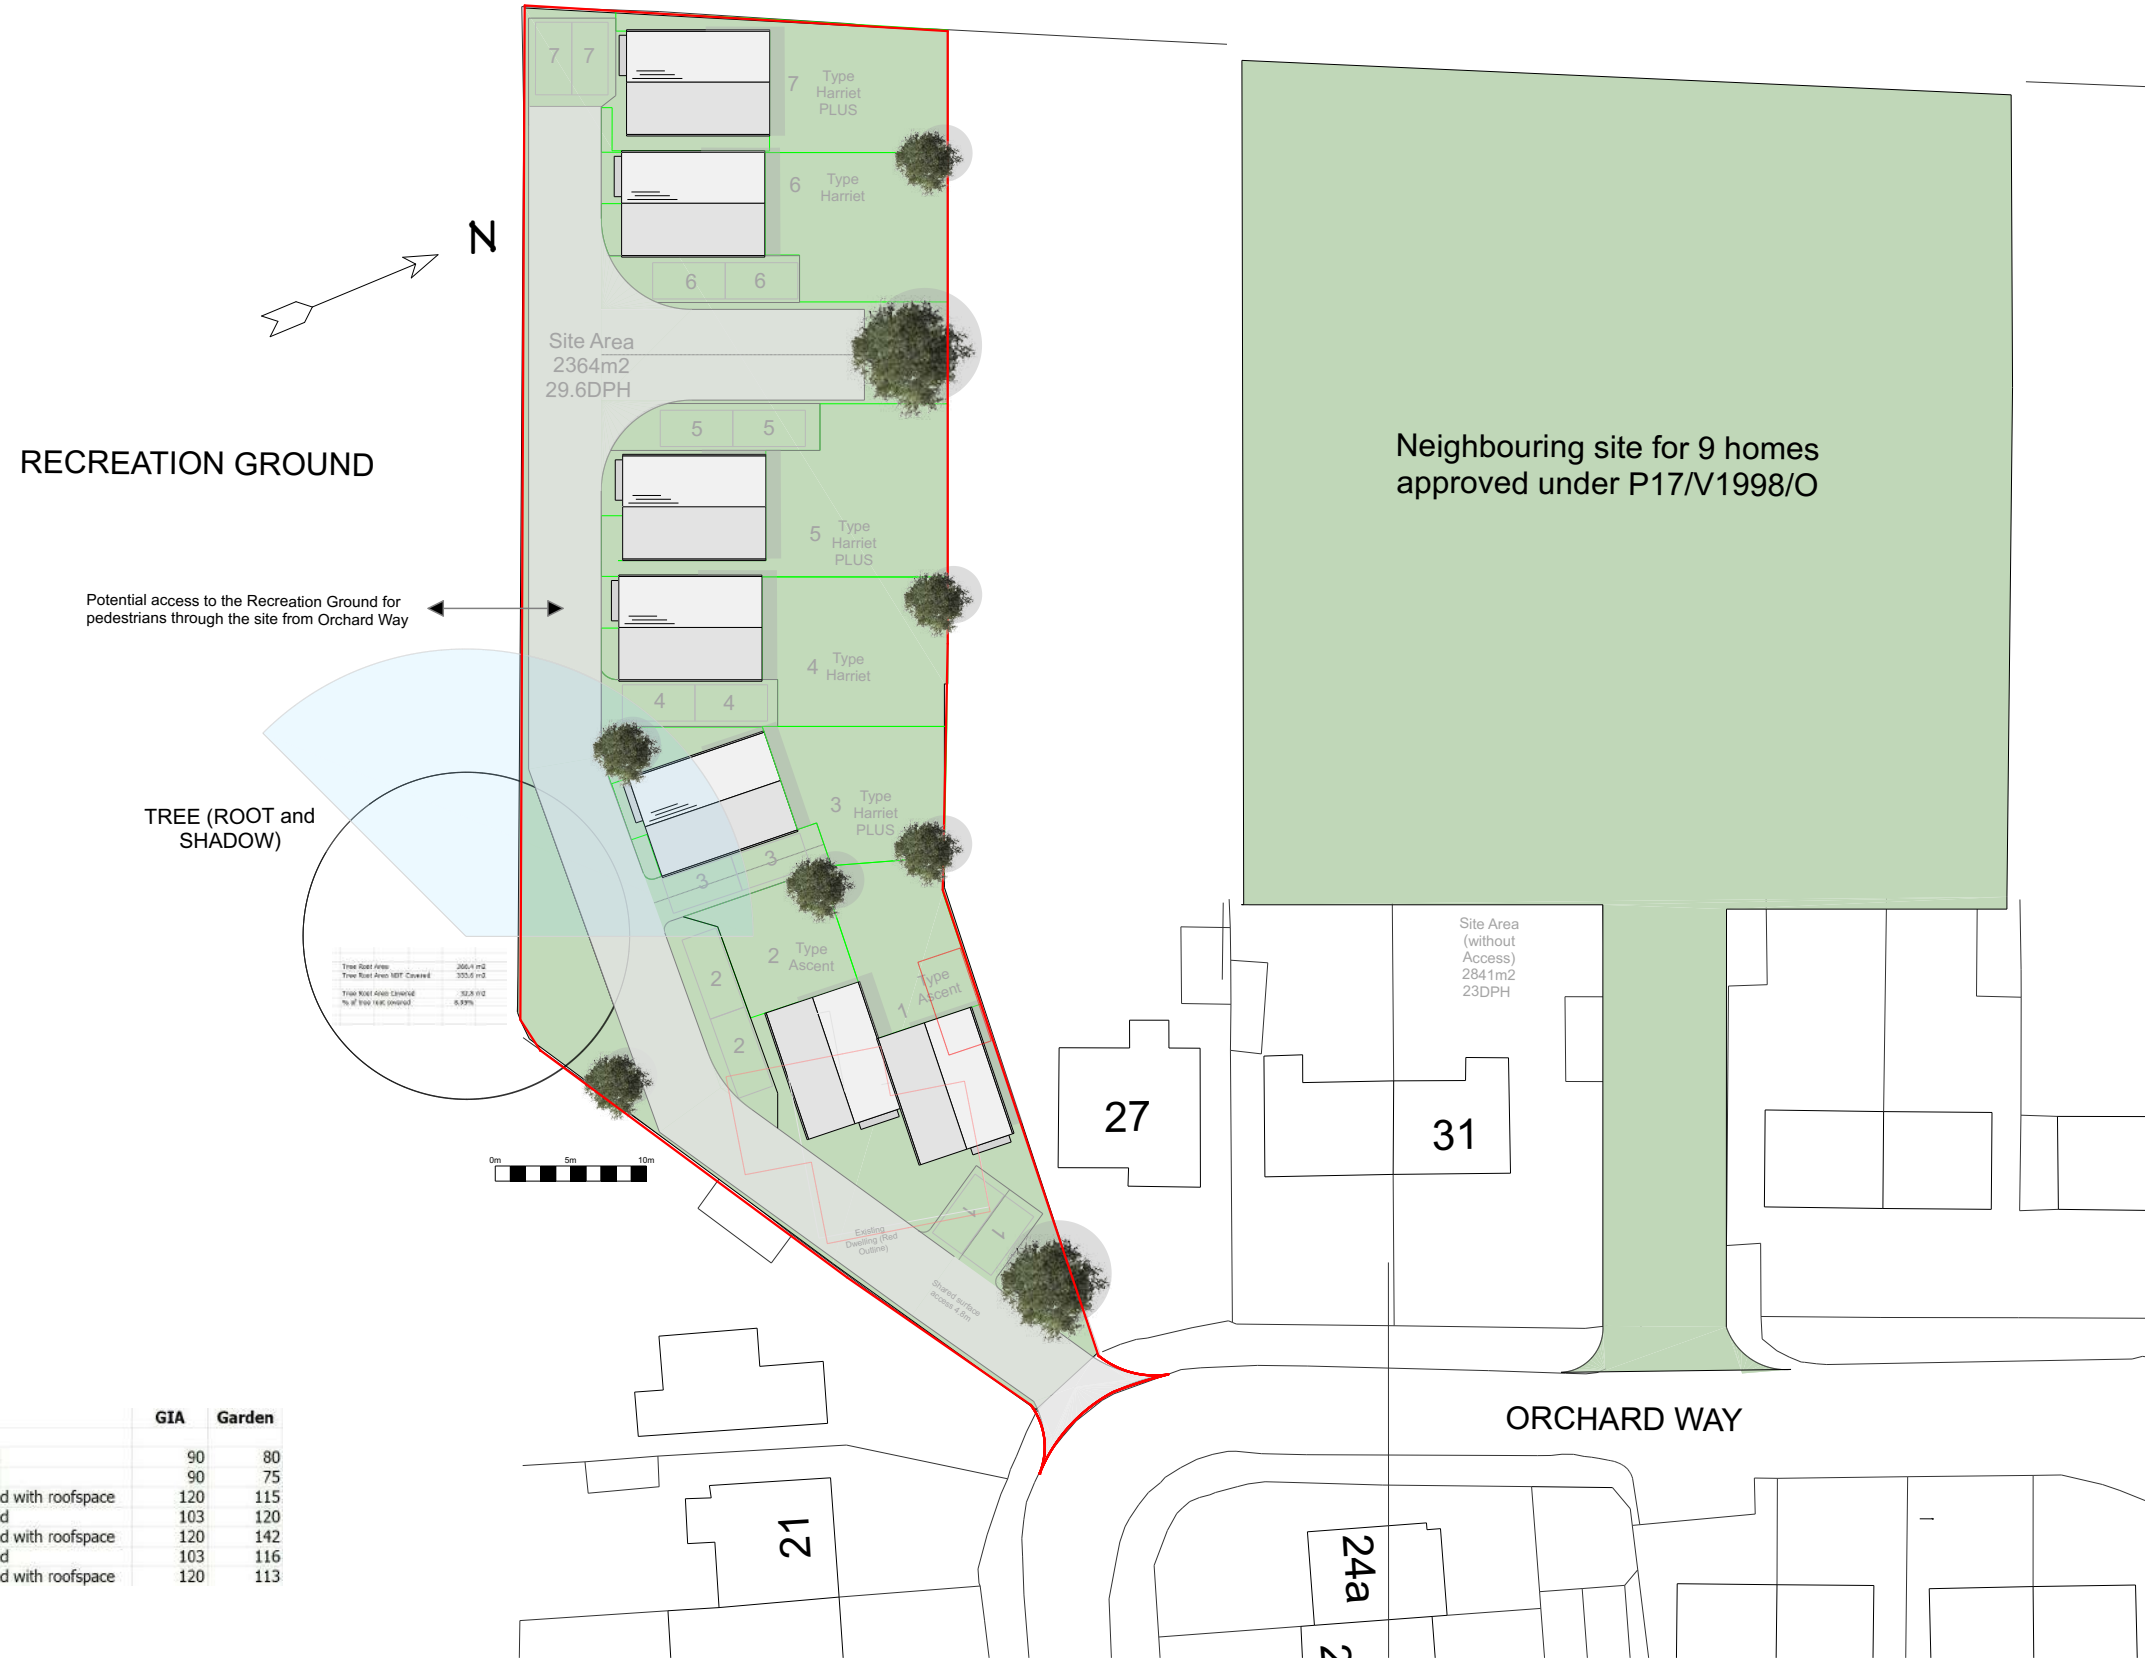
Client: **Feltham Construction**
 Project: **Harwell**
 Drawing Title: **Site Plan - Ground Floor**
 Scale: **1:100 @ A1**
 Date: **28.05.2019**

25 Orchard Way Harwell		GIA	Garden
Plot 1	2 Bed Ascent Detached	90	80
Plot 2	2 Bed Ascent Detached	90	75
Plot 3	4 Bed Hariette Detached with roofspace	120	115
Plot 4	3 Bed Hariette Detached	103	120
Plot 5	4 Bed Hariette Detached with roofspace	120	142
Plot 6	3 Bed Hariette Detached	103	116
Plot 7	4 Bed Hariette Detached with roofspace	120	113
