Heritage appraisal to support a planning application

For the conversion of Scotch Ones Laithe, Hellifield, North Yorkshire

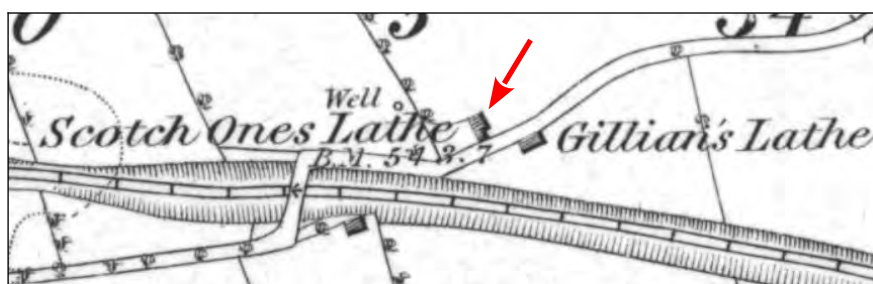
Figure 1: OS 1:10560 map, 1852

- 4.1 The barn is shown on the 1852 1:10560 scale Ordnance Survey map¹, with its current name, an L-shaped plan, and a foldyard to the west (figure 1). The nearby railway had been opened in 1849 and the adjacent road re-aligned to accommodate the new bridge over it, but this seems not to have affected the barn nor its immediate curtilage. No change is shown to the arrangement at the site on either the 1894 or the 1909 edition of the 1:2500 scale OS map² (figure 2).

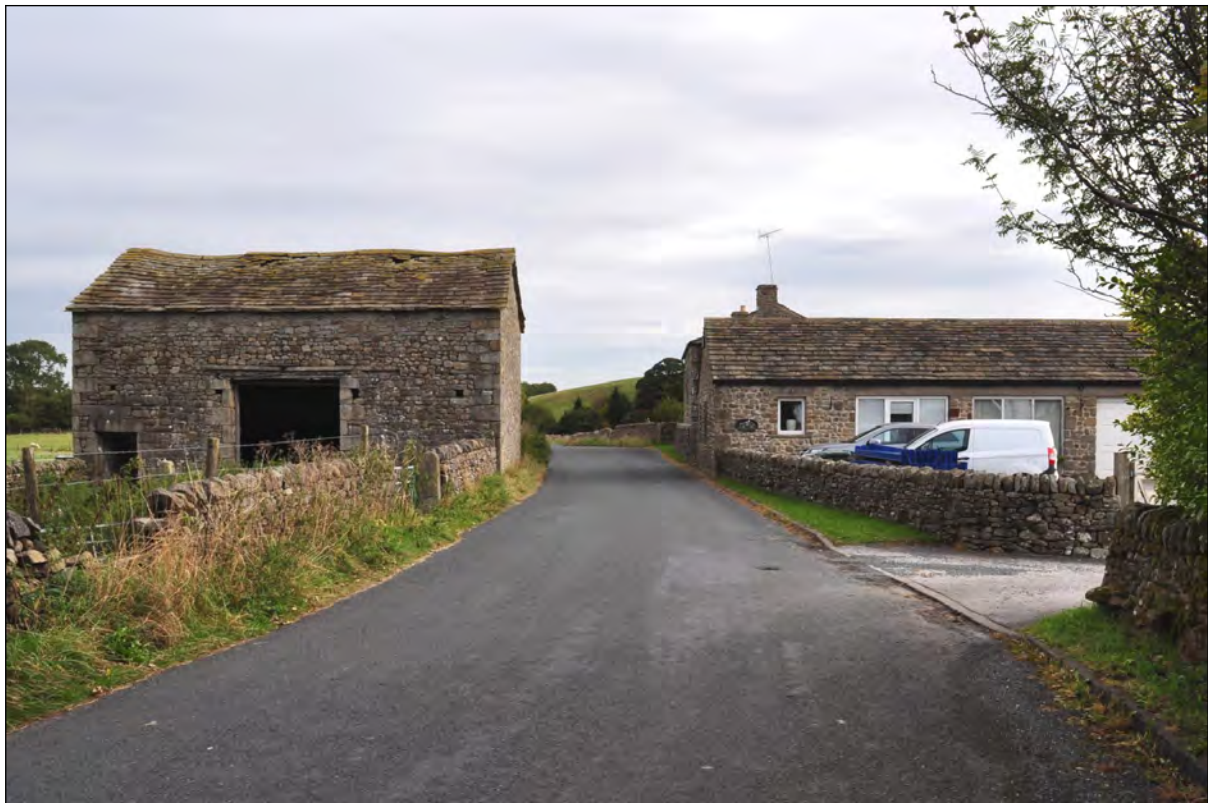
Photo 1: Setting: view along Malham Road, from the south-west

- 5.1 A dry-stone wall and the barn's south-east gable form the boundary to the adjacent road, opposite Gillian's Laithe (photo 1, below). A gateway through the wall, with dressed stone posts, provides access into the foldyard to the west of the barn, and there are two further gateways out from the yard, to the adjoining land. There are some modern sheep handling pens and runs to the north of the barn.

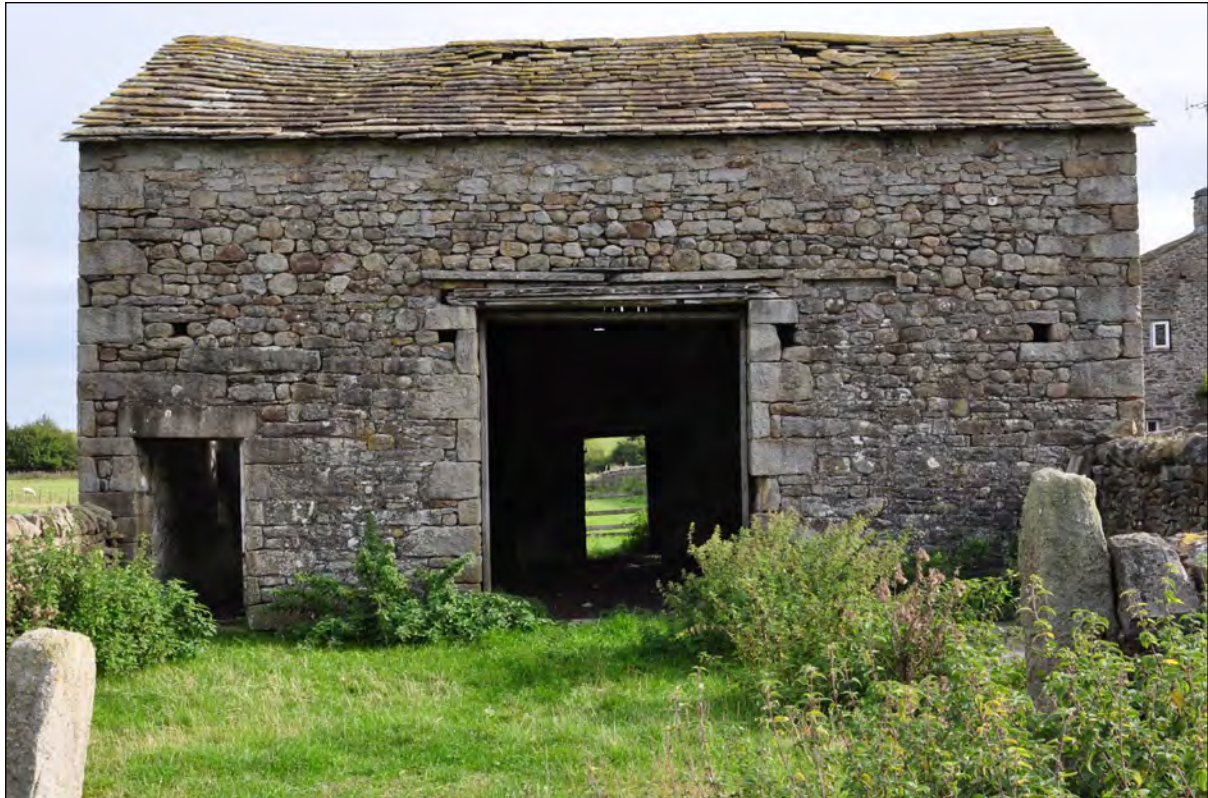
Photo 2: Front elevation

- 6.2 The building can be assigned to the category of "barns with wide shippons", for reasons which should be clear from the following account⁴.
- 6.3 The cart entrance in the south-west front has a timber lintel to the exterior, beneath a flagstone drip-band; the lintel has sockets in its underside for a pair of harr-hung doors, but nothing of them survives (photo 2). A smaller doorway to the left leads to the shippon: its lintel bears a shallow inscription reading "AB-1939-CH". A concrete pad within the yard, to the right of the cart entrance, suggests there was at one time an ephemeral structure adjoining there.

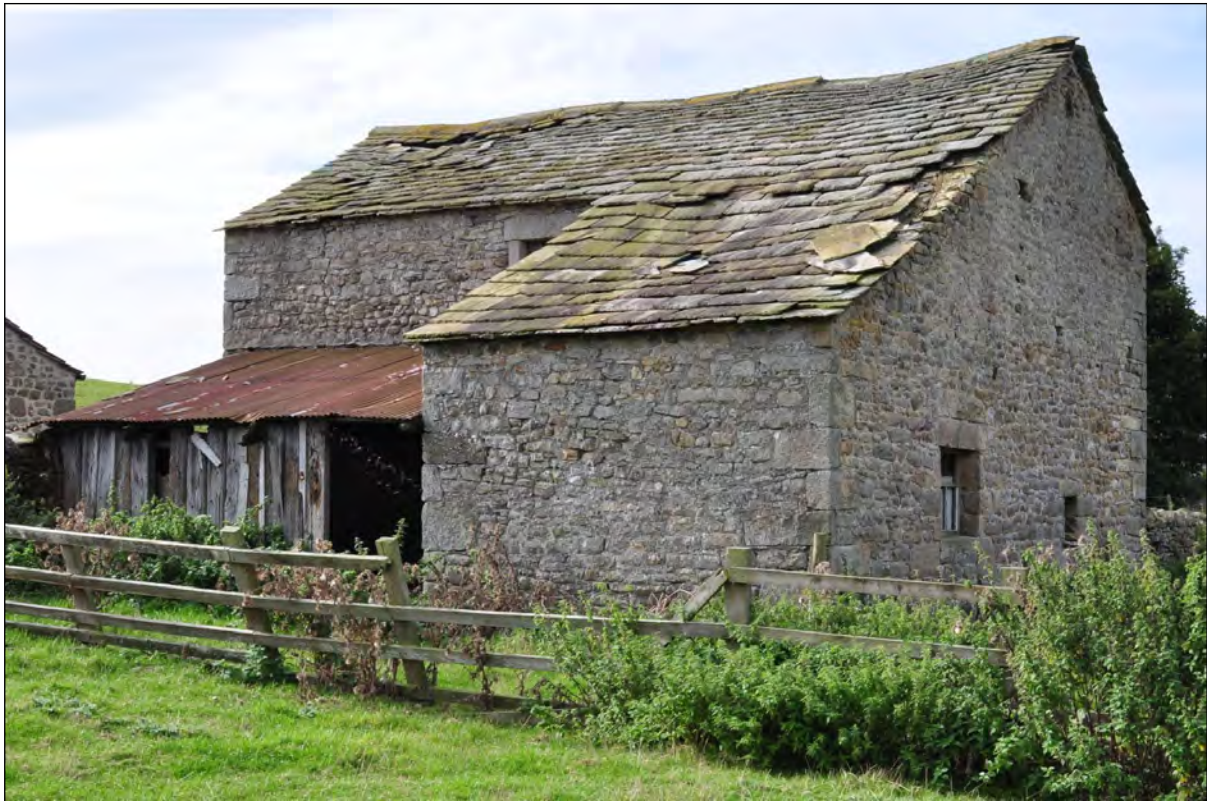
Photo 3: View from the north

- 6.4 The north-west gable appears to have been built in a single phase (indicating that the L-shaped plan is original), and contains a former doorway (now window), and a mucking-out hole (photo 3). A triangular owl-hole is incorporated near the ridge, and there is a similar owl-hole in the roadside gable, which is otherwise blind (photo 4).

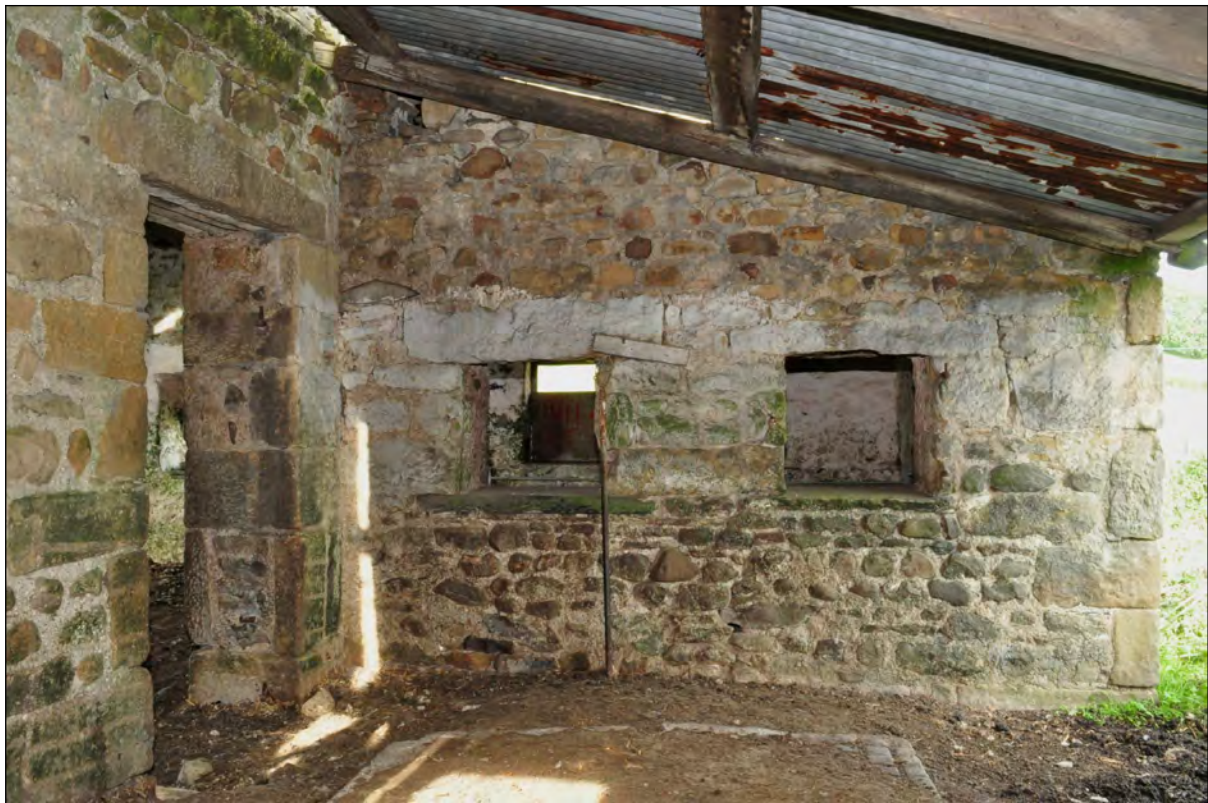
Photo 5: Winnowing doorway and feeding holes, now within lean-to

- 6.5 To the rear of the barn are the winnowing doorway, opposite the cart entrance, and a forking hole above, with monolithic jambs and internally hung shutter. (The position of the forking hole here is slightly odd, as it appears not to have been located over the hayloft.) The south-east side wall of the projecting bay has two feeding holes serving stalls in the shippon; the openings appear to be original, and one of them has hinge pintles for an external shutter (photo 5).

These openings are another unusual aspect to the barn. The mid twentieth century lean-to now enclosing this area incorporates the roadside boundary wall, and is mostly constructed from vertical railway sleepers, with a corrugated iron roof. It would have provided additional livestock stalls.

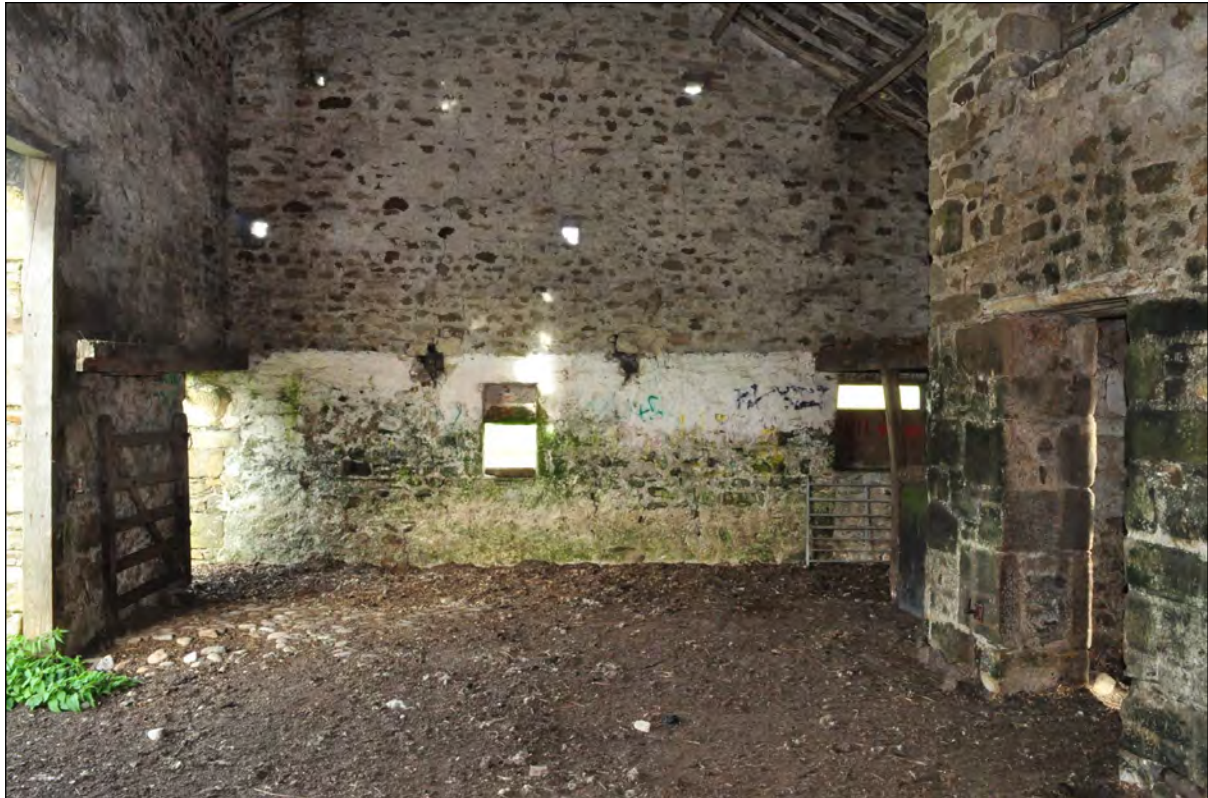
Photo 6: Interior: view from south-east, towards former shippon

- 6.6 The interior of the stone building forms a single open space, albeit with the remnants of a shippon and hayloft within the projecting northern part; these structures would no doubt have occupied the full width of the building originally, within this bay (photo 6). The surviving boskins have frames of local hardwood timber with elbowed heel-posts, and slate panels (Horton flags), and they form standings for four animals in two pairs, each pair being provided with a feeding hole in the wall to the front (photo 7). There are two softwood beams of more modern date supporting the hayloft (baulks) over them, and sockets in the gable wall indicate that two more boskins and hayloft beams have been removed, so the building would have held stalls for ten animals in total. The present arrangement raises the question as to why there should have been a doorway in the gable, and perhaps there was an internal division within the shippon at one time, meaning that the four stalls at the end were not otherwise accessible, a scenario which would also account for their feeding holes.

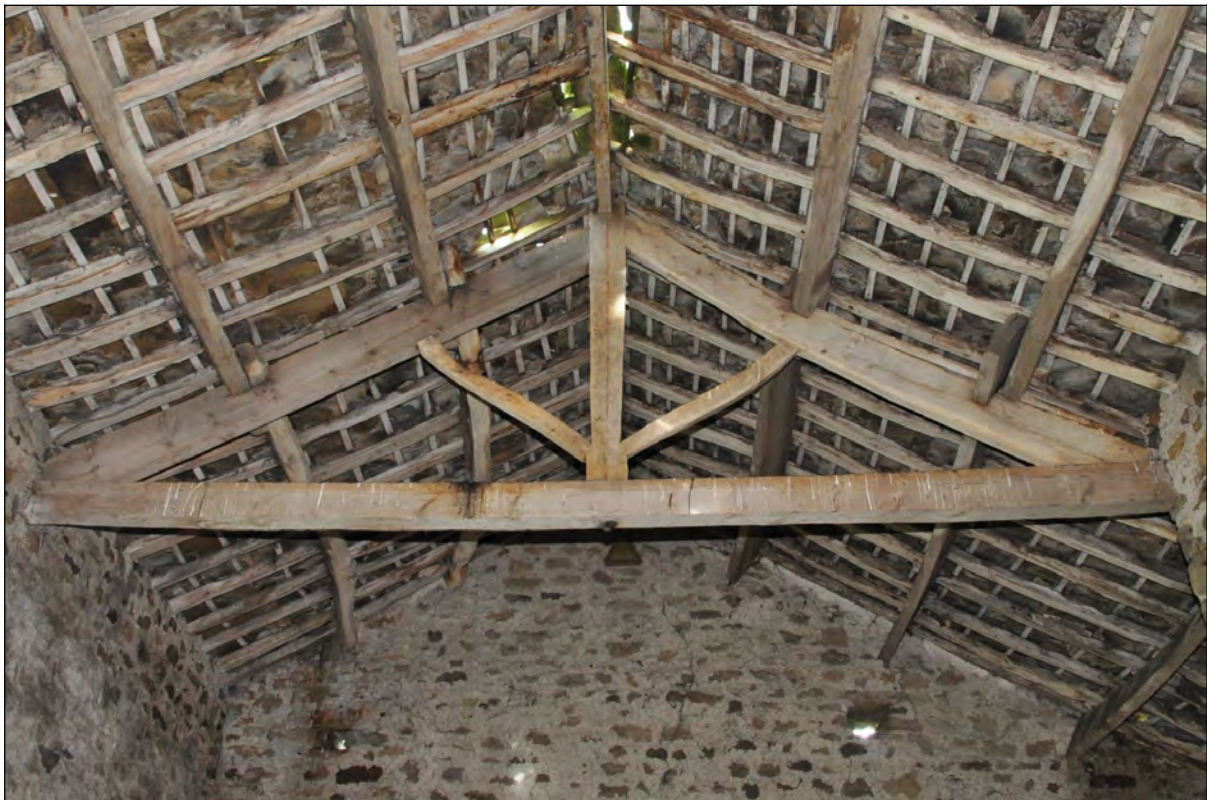
Photo 8: North-west roof truss, with mixture of timber types

- 6.8 The barn roof is borne on two bolted, king-post trusses which combine local hardwood and imported softwood timbers, most likely as a result of repair and replacement. The north-west truss (photo 8) has more local timber than the south-east truss: its hardwood parts include one of the principal rafters, the king-post, and its raking trusses, while the tie-beam and other principal rafter are of imported softwood. Similarly, the barn's purlins are a mixture of such timber, and are further evidence for repairs to the roof.
