70 VICTORIA STREET  
GALASHIELS  
TD1 1HJ

# Home Report

70 VICTORIA STREET, GALASHIELS, TD1 1HJ

# Scottish Single Survey

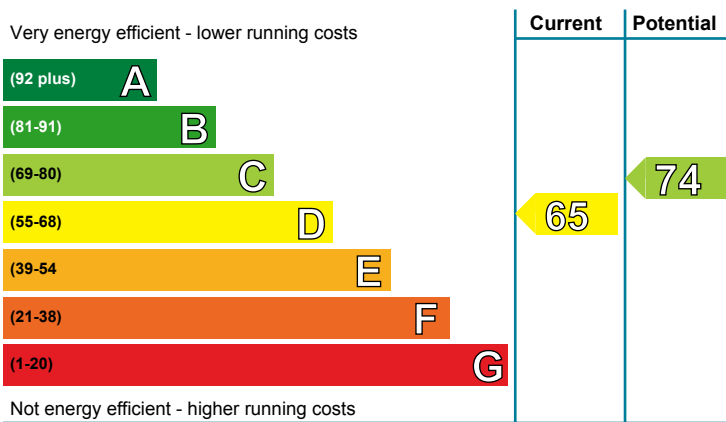
## Energy Efficiency Rating

This graph shows the current efficiency of your home, taking into account both energy efficiency and fuel costs. The higher this rating, the lower your fuel bills are likely to be.

Your current rating is **band D (65)**. The average rating for EPCs in Scotland is **band D (61)**.

The potential rating shows the effect of undertaking all of the improvement measures listed within your recommendations report.

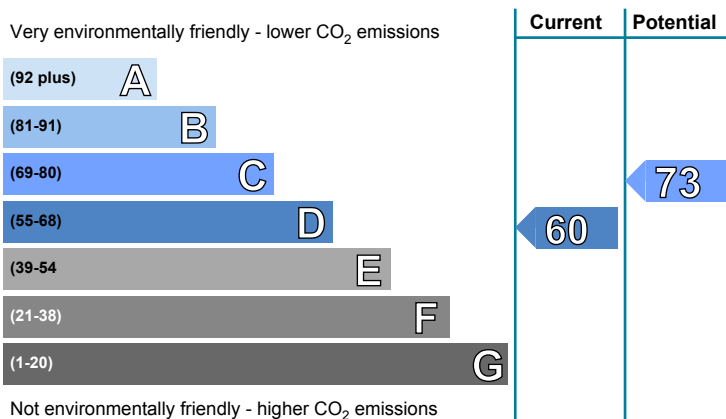
## Environmental Impact (CO<sub>2</sub>) Rating

This graph shows the effect of your home on the environment in terms of carbon dioxide (CO<sub>2</sub>) emissions. The higher the rating, the less impact it has on the environment.

Your current rating is **band D (60)**. The average rating for EPCs in Scotland is **band D (59)**.

The potential rating shows the effect of undertaking all of the improvement measures listed within your recommendations report.
