# Home Report

**Property address:** New Brimbanks  
Eday  
Orkney  
KW17 2AA

## 1. INFORMATION AND SCOPE OF INSPECTION

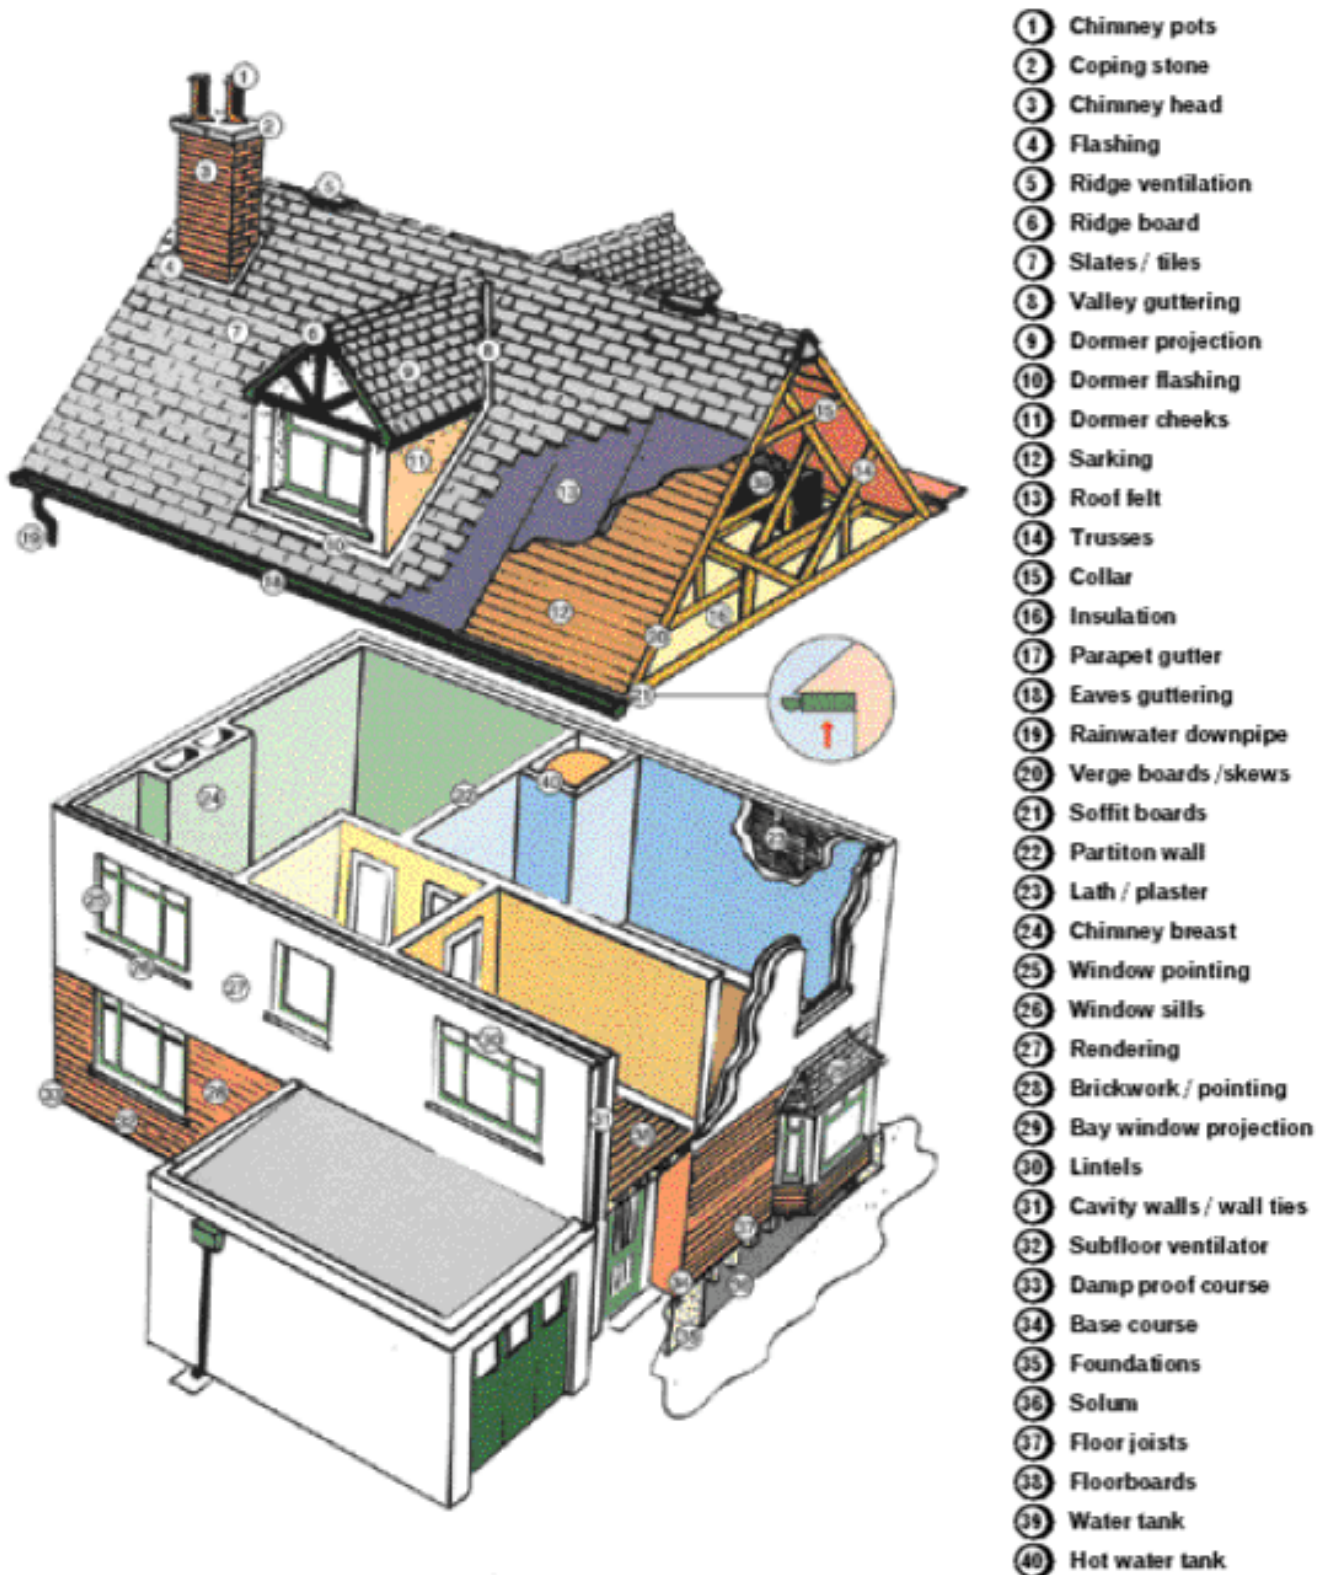
## Sectional diagram showing elements of a typical house

Reference may be made in this report to some or all of the above component parts of the property. This diagram may assist you in locating and understanding these terms.
