# Single Survey

<b>Property address</b>	109 WATERMILL ROAD FRASERBURGH ABERDEENSHIRE AB43 9RH
<b>Customer</b>	D SCOTHERN
<b>Customer address</b>	
<b>Prepared by</b>	HOME REPORT COMPANY
<b>Date of Inspection</b>	31 <sup>ST</sup> AUGUST 2022

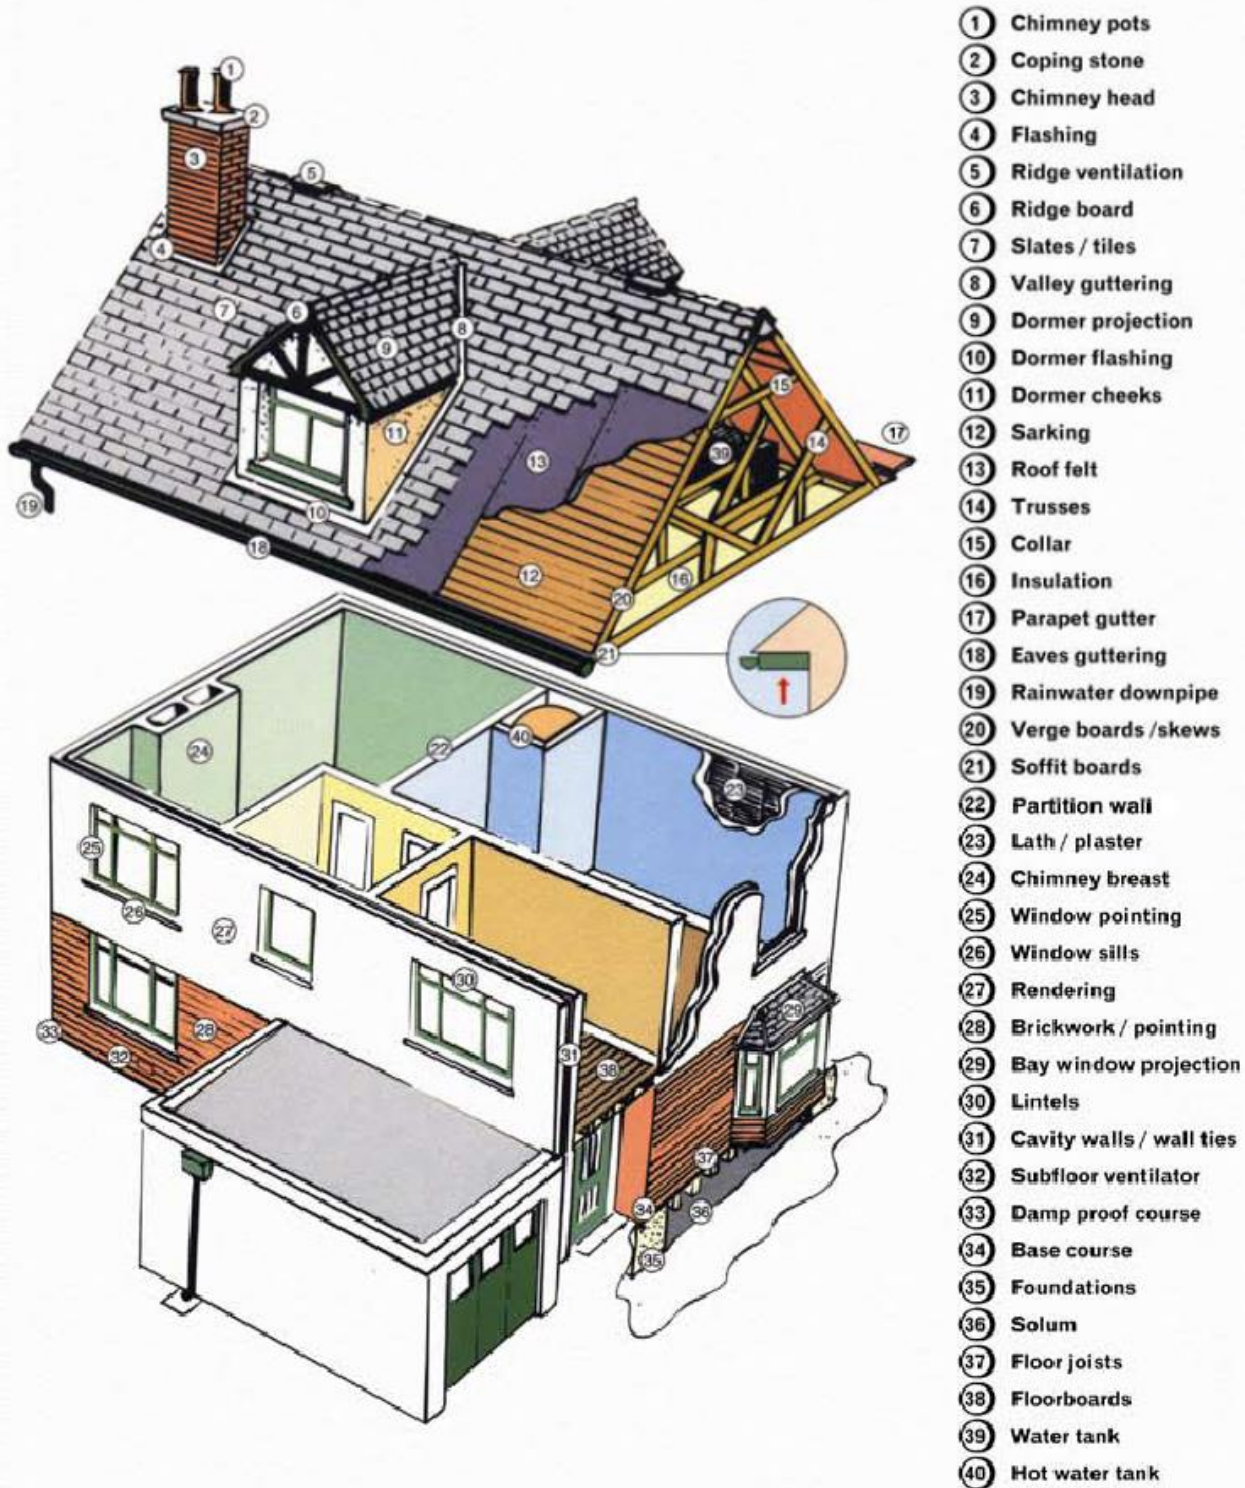
## Sectional Diagram showing elements of a typical house

Reference may be made in this report to some or all of the above component parts of the property. This diagram may assist you in locating and understanding these items.
