Single Survey

survey report on:

| Property address | Flat 29, 11 Oxgangs Road North, Oxgangs, EDINBURGH, EH13 9AA |

| Prepared by | ALLIED SURVEYORS SCOTLAND PLC |

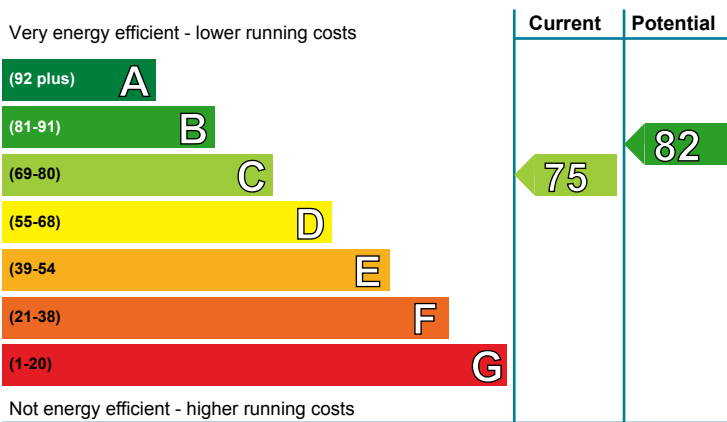
Energy Efficiency Rating

This graph shows the current efficiency of your home, taking into account both energy efficiency and fuel costs. The higher this rating, the lower your fuel bills are likely to be.

Your current rating is **band C (75)**. The average rating for EPCs in Scotland is **band D (61)**.

The potential rating shows the effect of undertaking all of the improvement measures listed within your recommendations report.

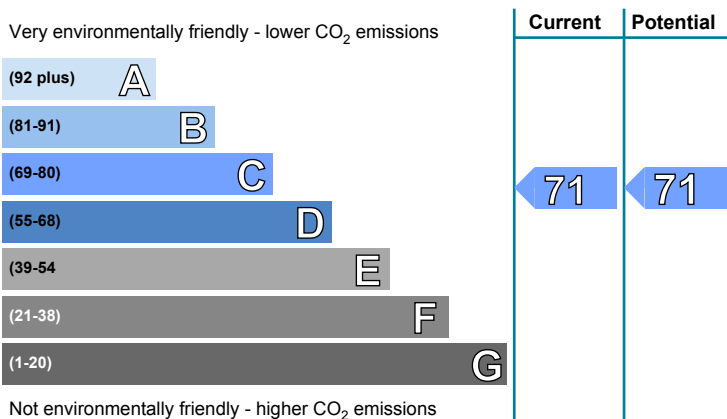
Environmental Impact (CO₂) Rating

This graph shows the effect of your home on the environment in terms of carbon dioxide (CO₂) emissions. The higher the rating, the less impact it has on the environment.

The potential rating shows the effect of undertaking all of the improvement measures listed within your recommendations report.
