YOUR ONESURVEY  
**HOME REPORT**

Flat 3/2  
61 Terregles Crescent  
Glasgow  
G41 4RL

# SINGLE SURVEY

# Single Survey

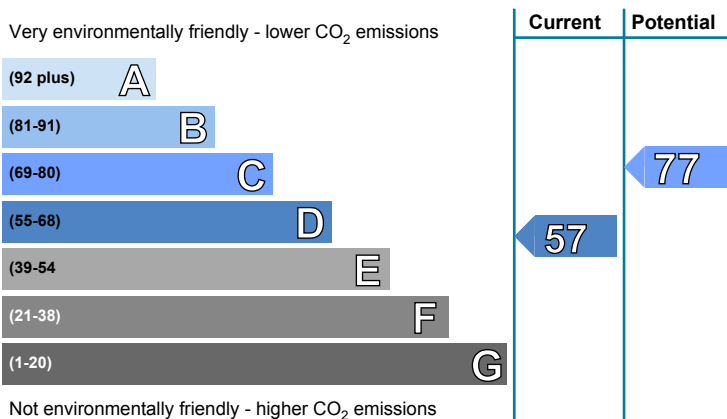
## Environmental Impact (CO<sub>2</sub>) Rating

This graph shows the effect of your home on the environment in terms of carbon dioxide (CO<sub>2</sub>) emissions. The higher the rating, the less impact it has on the environment.
