YOUR ONESURVEY HOME REPORT

Flat 2/2 1322 London Road Glasgow G31 4LD

SINGLE SURVEY

Single Survey

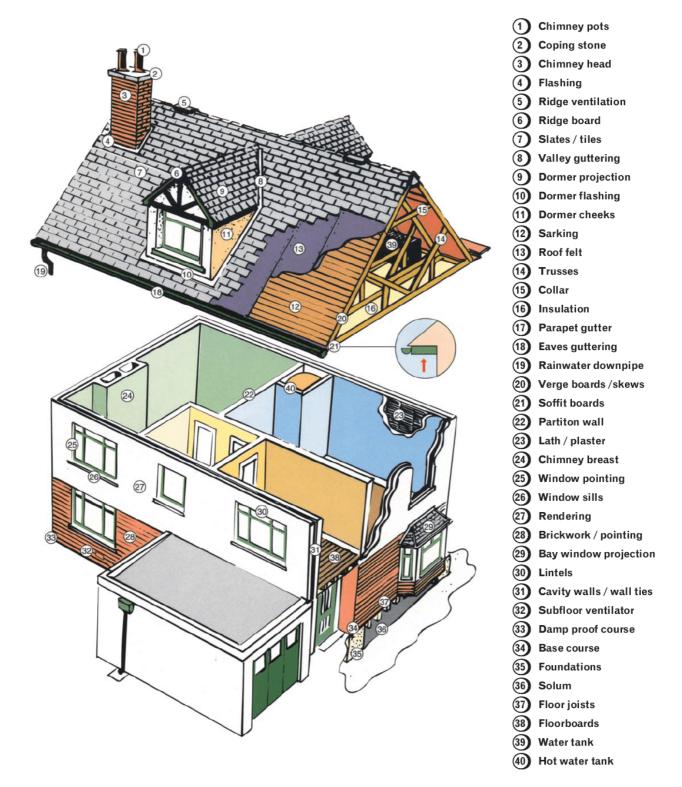
Sectional Diagram showing elements of a typical house

Reference may be made in this report to some or all of the above component parts of the property. This diagram may assist you in locating and understanding these items.
