HOME REPORT

FLAT 11
31 OCEAN DRIVE
NORTH LEITH
EDINBURGH
EH6 6JL

Energy Performance Certificate (EPC)

FLAT 11 , 31 OCEAN DRIVE, NORTH LEITH, EDINBURGH, EH6 6JL

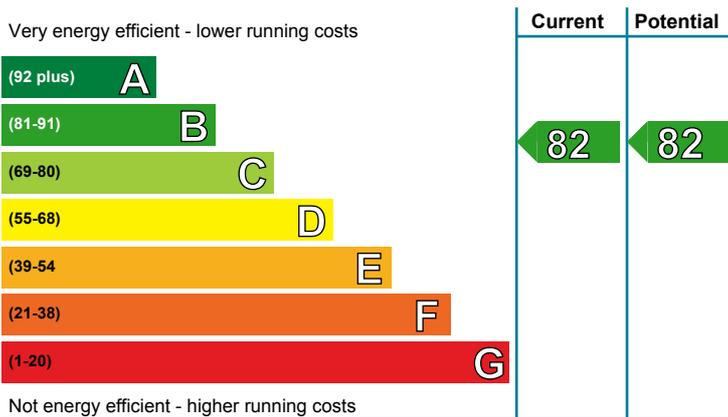
Energy Efficiency Rating

This graph shows the current efficiency of your home, taking into account both energy efficiency and fuel costs. The higher this rating, the lower your fuel bills are likely to be.

Your current rating is **band B (82)**. The average rating for EPCs in Scotland is **band D (61)**.

The potential rating shows the effect of undertaking all of the improvement measures listed within your recommendations report.

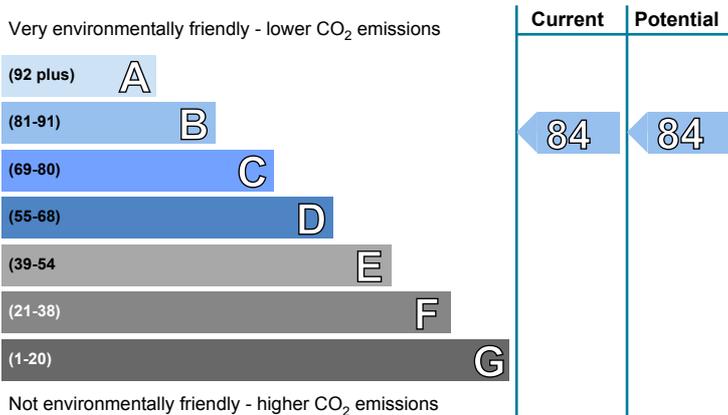
Environmental Impact (CO₂) Rating

This graph shows the effect of your home on the environment in terms of carbon dioxide (CO₂) emissions. The higher the rating, the less impact it has on the environment.

Your current rating is **band B (84)**. The average rating for EPCs in Scotland is **band D (59)**.

The potential rating shows the effect of undertaking all of the improvement measures listed within your recommendations report.
