HOME REPORT

TULACH BEAG ACHNANDARACH

PLOCKTON
IV52 8TY

Single Survey

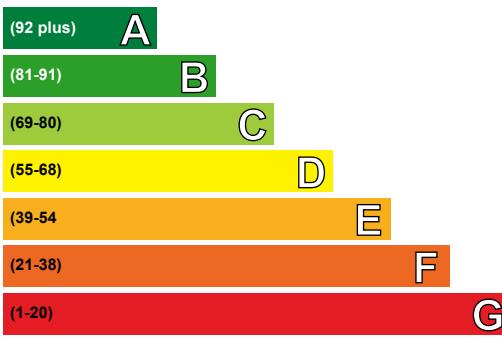
Energy Efficiency Rating

This graph shows the current efficiency of your home, taking into account both energy efficiency and fuel costs. The higher this rating, the lower your fuel bills are likely to be.

Your current rating is **band D (62)**. The average rating for EPCs in Scotland is **band D (61)**.

The potential rating shows the effect of undertaking all of the improvement measures listed within your recommendations report.
