HARVEY DONALDSON & GIBSON

survey report on:

, , , , , , , , , , , , , , , , , , ,	
Property address	18 George Street, Fraserburgh, AB43 9QR
Customer	Mr Chang Min Yu
Customer address	
Prepared by	Harvey Donaldson And Gibson
Date of inspection	14th February 2023

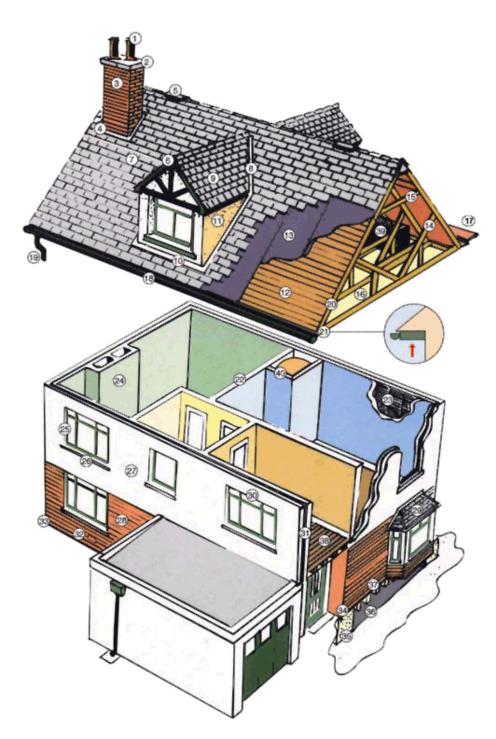
Sectional Diagram showing elements of a typical house

Reference may be made in this report to some or all of the above component parts of the property. This diagram may assist you in locating and understanding these items.

- 1) Chimney pots
- 2) Coping stone
- 3) Chimney head
- 4 Flashing
- 5 Ridge ventilation
- 6 Ridge board
- 7) Slates / tiles
- 8 Valley guttering
- 9 Dormer projection
- 10 Dormer flashing
- 11) Dormer cheeks
- 12) Sarking
- (13) Roof felt
- (14) Trusses
- (15) Collar
- 16 Insulation
- (17) Parapet gutter
- 18) Eaves guttering
- 19) Rainwater downpipe
- 20) Verge boards/skews
- 21) Soffit boards
- 22) Partition wall
- 23) Lath / plaster
- 24) Chimney breast
- 25) Window pointing
- 6) Window sills
- 27) Rendering
- (28) Brickwork / pointing
- 29) Bay window projection
- (30) Lintels
- (31) Cavity walls / wall ties
- 32) Subfloor ventilator
- 33) Damp proof course
- 34) Base course
- 35) Foundations
- (36) Solum
- 37) Floor joists
- 38) Floorboards
- 39) Water tank
- 40) Hot water tank
