Home Report

149 (1F1) Liberton Brae Edinburgh EH16 6LD

single survey

survey report on:

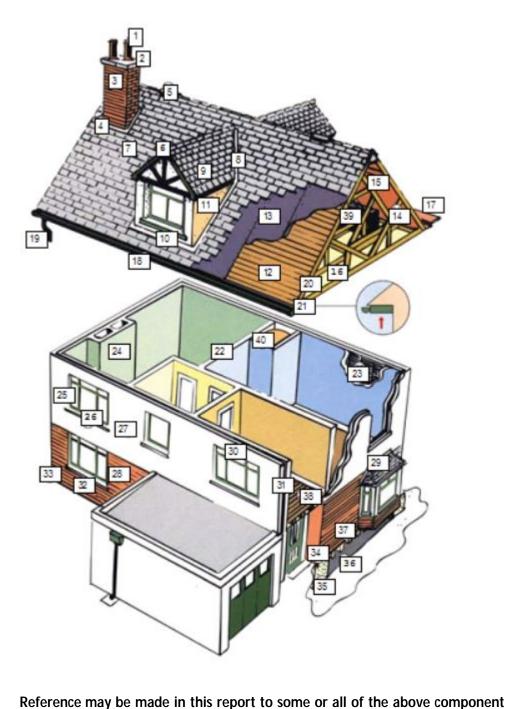
Sectional Diagram showing elements of a typical house

Chimney pots 1 Coping stone 2 3 Chimney head Flashing 4 Ridge ventilation 5 Ridge board 6 7 Slates/tiles 8 Valley guttering 9 Dormer projection Dormer flashing 10 Dormer cheeks 11 12 Sarking Roof felt 13 Trusses 14 15 Collar 16 Insulation 17 Parapet gutter Eaves guttering 18 Rainwater downpipe 19 20 Verge boards / skews 21 Soffit boards 22 Partition wall Lath / plaster 23 24 Chimney breast 25 Window pointing Window sills 26 27 Rendering Brickwork / pointing 28 Bay window 29 30 Lintels 31 Cavity walls / wall ties Subfloor ventilator 32 33 Damp proof course 34 Base course 35 Foundations Solum 36 37 Floor joists Floorboards 38 Water tank 39 40 Hot water tank parts of the property. This diagram may assist you in locating and understanding
