PROPERTY QUESTIONNAIRE

Property address:	32b Moat Terrace Edinburgh EH141PS
-------------------	--

Single Survey

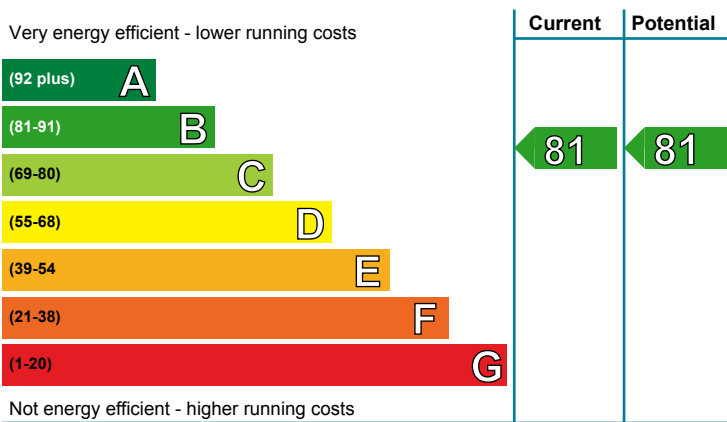
Energy Efficiency Rating

This graph shows the current efficiency of your home, taking into account both energy efficiency and fuel costs. The higher this rating, the lower your fuel bills are likely to be.

Your current rating is **band B (81)**. The average rating for EPCs in Scotland is **band D (61)**.

The potential rating shows the effect of undertaking all of the improvement measures listed within your recommendations report.
