# Home Report

# Scottish Single Survey

## survey report on:

Property address	95 Millburn Crescent Armadale Bathgate EH48 3RD
Customer	Anne Mclean
Customer address	95 Millburn Crescent Armadale Bathgate EH48 3RD
Prepared by	Shepherd Chartered Surveyors
Date of inspection	17/07/2023

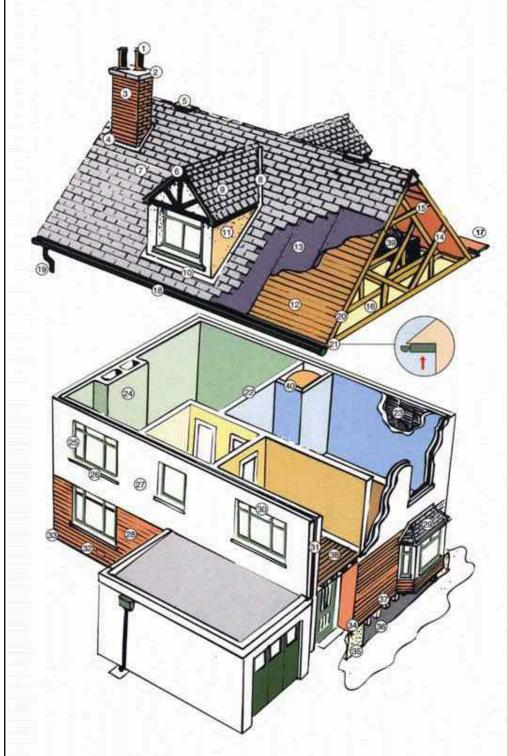
### Sectional Diagram showing elements of a typical house

Reference may be made in this report to some or all of the above component parts of the property. This diagram may assist you in locating and understanding these items.

- 1) Chimney pots
- 2) Coping stone
- 3 Chimney head
- (4) Flashing
- 5) Ridge ventilation
- 6) Ridge board
- (7) Slates / tiles
- 8 Valley guttering
- 9 Dormer projection
- 10 Dormer flashing
- 11 Dormer cheeks
- (12) Sarking
- (13) Roof felt
- (14) Trusses
- (15) Collar
- 16) Insulation
- (17) Parapet gutter
- 18) Eaves guttering
- (19) Rainwater downpipe
- 20) Verge boards /skews
- 21) Soffit boards
- 22) Partition wall
- 23) Lath / plaster
- (24) Chimney breast
- 25) Window pointing
- 26) Window sills
- 27) Rendering
- 28) Brickwork / pointing
- (29) Bay window projection
- (30) Lintels
- (31) Cavity walls / wall ties
- 32) Subfloor ventilator
- (33) Damp proof course
- 34) Base course
- (35) Foundations
- 36) Solum
- 37) Floor joists
- 8) Floorboards
- 39) Water tank
- 40) Hot water tank
