Single Survey

Property address	Flat 30, 25 Barnton Grove, EDINBURGH, EH4 6EZ
-------------------------	--

Prepared by	ALLIED SURVEYORS SCOTLAND PLC
--------------------	-------------------------------

Date of inspection	4th September 2023
---------------------------	--------------------

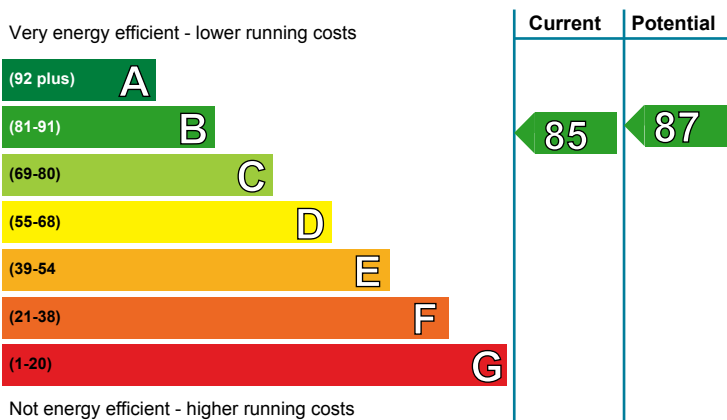
Energy Efficiency Rating

This graph shows the current efficiency of your home, taking into account both energy efficiency and fuel costs. The higher this rating, the lower your fuel bills are likely to be.

Your current rating is **band B (85)**. The average rating for EPCs in Scotland is **band D (61)**.

The potential rating shows the effect of undertaking all of the improvement measures listed within your recommendations report.

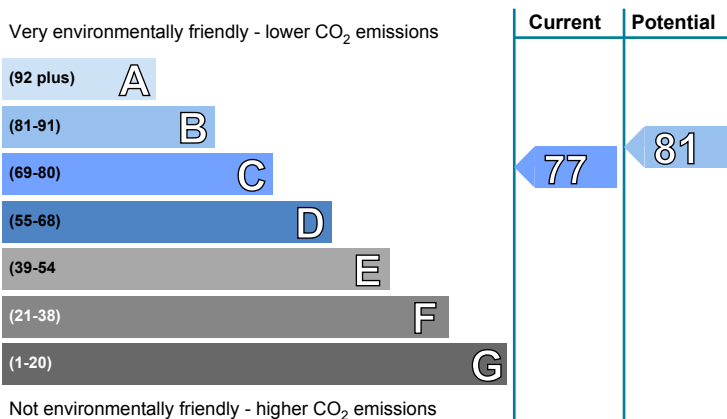
Environmental Impact (CO₂) Rating

This graph shows the effect of your home on the environment in terms of carbon dioxide (CO₂) emissions. The higher the rating, the less impact it has on the environment.

The potential rating shows the effect of undertaking all of the improvement measures listed within your recommendations report.
