Home Report

Scottish Single Survey

Property address	1 Doo'Cot Brae Alloa FK10 2NP
-------------------------	-------------------------------------

Prepared by	Shepherd Chartered Surveyors
--------------------	------------------------------

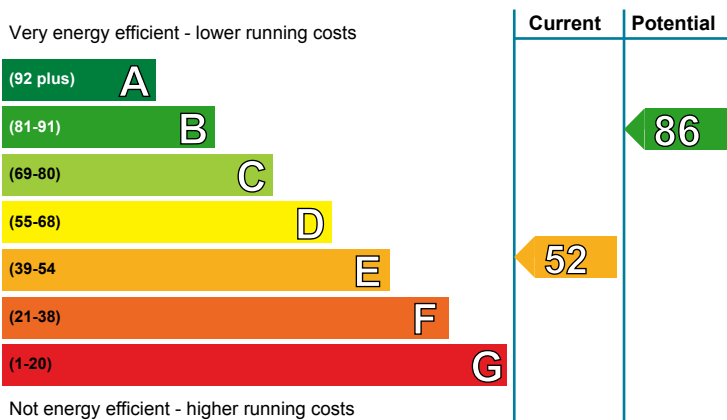
Energy Efficiency Rating

This graph shows the current efficiency of your home, taking into account both energy efficiency and fuel costs. The higher this rating, the lower your fuel bills are likely to be.

Your current rating is **band E (52)**. The average rating for EPCs in Scotland is **band D (61)**.

The potential rating shows the effect of undertaking all of the improvement measures listed within your recommendations report.

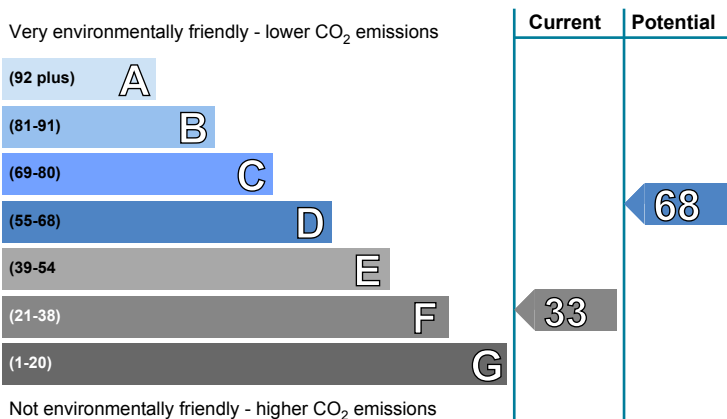
Environmental Impact (CO₂) Rating

This graph shows the effect of your home on the environment in terms of carbon dioxide (CO₂) emissions. The higher the rating, the less impact it has on the environment.
