YOUR ONESURVEY
HOME REPORT

125 Dalnabay
Silverglades, Aviemore
PH22 1TD

SINGLE SURVEY

Single Survey

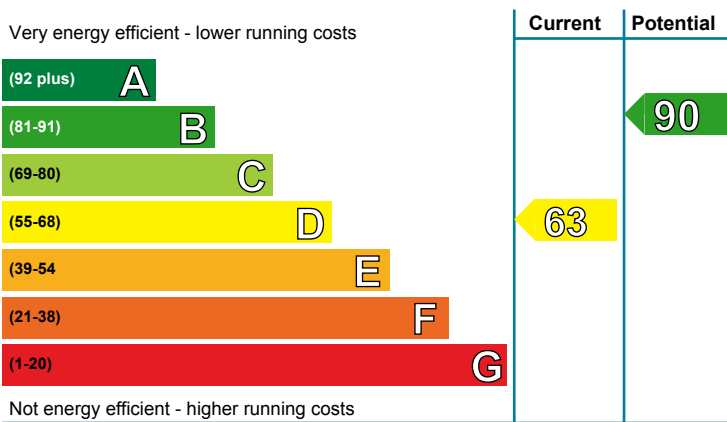
Energy Efficiency Rating

This graph shows the current efficiency of your home, taking into account both energy efficiency and fuel costs. The higher this rating, the lower your fuel bills are likely to be.

Your current rating is **band D (63)**. The average rating for EPCs in Scotland is **band D (61)**.

The potential rating shows the effect of undertaking all of the improvement measures listed within your recommendations report.

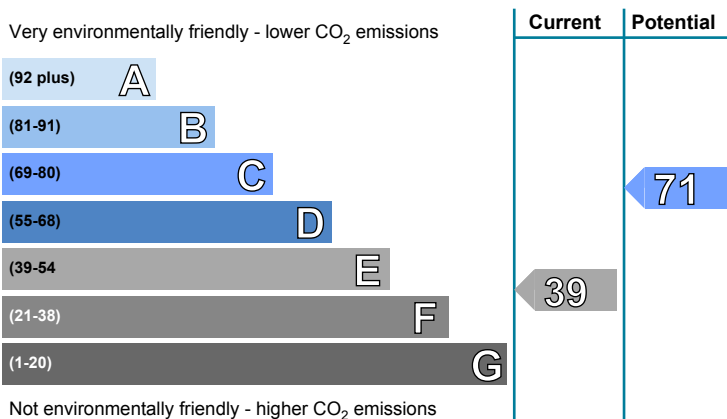
Environmental Impact (CO₂) Rating

This graph shows the effect of your home on the environment in terms of carbon dioxide (CO₂) emissions. The higher the rating, the less impact it has on the environment.
