# Home Report

# Scottish Single Survey

<b>Property address</b>	Beumaris Carsethorn Dumfries DG2 8DS
-------------------------	---

<b>Date of inspection</b>	14/09/2023
---------------------------	------------

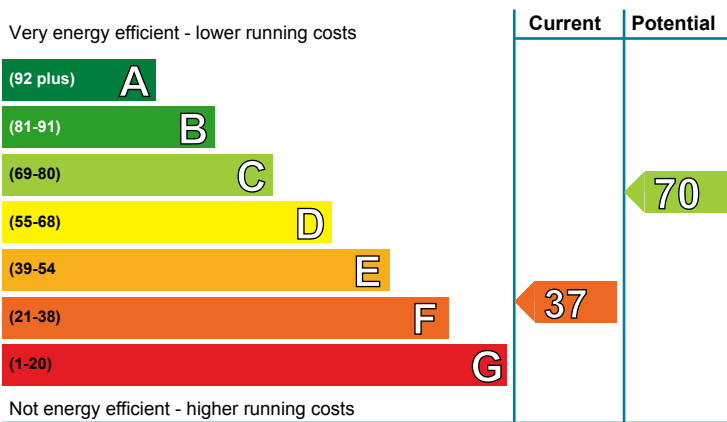
## Energy Efficiency Rating

This graph shows the current efficiency of your home, taking into account both energy efficiency and fuel costs. The higher this rating, the lower your fuel bills are likely to be.

Your current rating is **band F (37)**. The average rating for EPCs in Scotland is **band D (61)**.

The potential rating shows the effect of undertaking all of the improvement measures listed within your recommendations report.

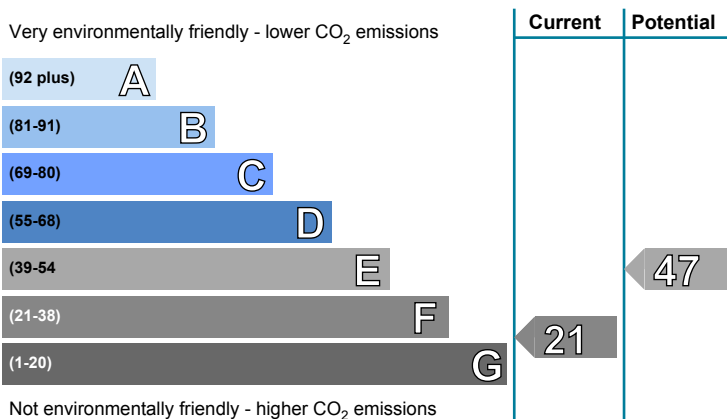
## Environmental Impact (CO<sub>2</sub>) Rating

This graph shows the effect of your home on the environment in terms of carbon dioxide (CO<sub>2</sub>) emissions. The higher the rating, the less impact it has on the environment.
