HOME REPORT

47 JORDAN LANE
MORNINGSIDE
EDINBURGH
EH10 4QX

ENERGY PERFORMANCE CERTIFICATE

Single Survey

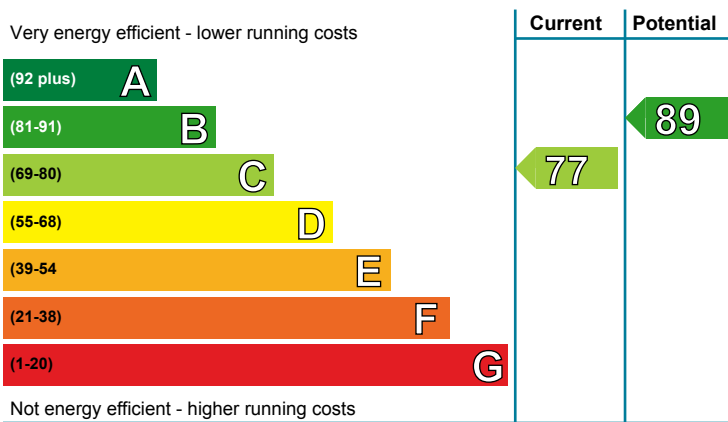
Energy Efficiency Rating

This graph shows the current efficiency of your home, taking into account both energy efficiency and fuel costs. The higher this rating, the lower your fuel bills are likely to be.

Your current rating is **band C (77)**. The average rating for EPCs in Scotland is **band D (61)**.

The potential rating shows the effect of undertaking all of the improvement measures listed within your recommendations report.

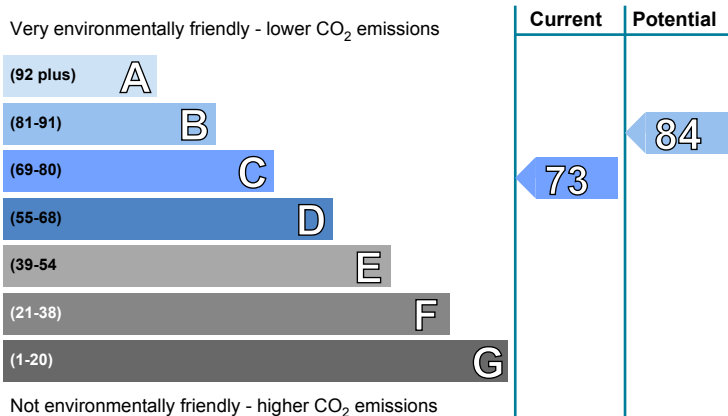
Environmental Impact (CO₂) Rating

This graph shows the effect of your home on the environment in terms of carbon dioxide (CO₂) emissions. The higher the rating, the less impact it has on the environment.

Your current rating is **band C (73)**. The average rating for EPCs in Scotland is **band D (59)**.

The potential rating shows the effect of undertaking all of the improvement measures listed within your recommendations report.
