HOME REPORT

QUAY HOUSE HARBOUR STREET

TARBERT
PA29 6UD

Energy Performance Certificate (EPC)

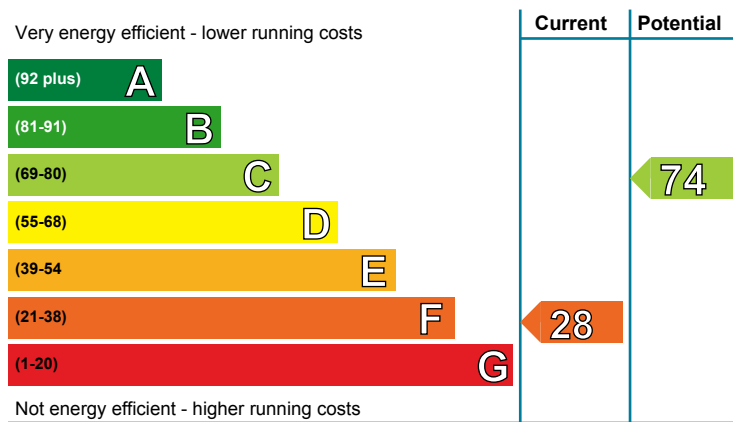
Energy Efficiency Rating

This graph shows the current efficiency of your home, taking into account both energy efficiency and fuel costs. The higher this rating, the lower your fuel bills are likely to be.

Your current rating is **band F (28)**. The average rating for EPCs in Scotland is **band D (61)**.

The potential rating shows the effect of undertaking all of the improvement measures listed within your recommendations report.

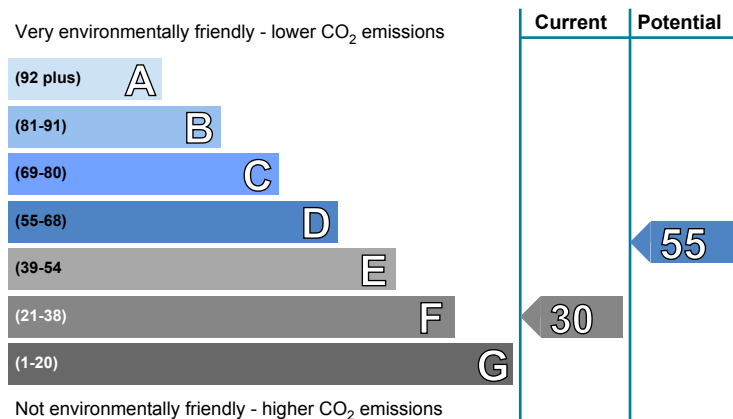
Environmental Impact (CO₂) Rating

This graph shows the effect of your home on the environment in terms of carbon dioxide (CO₂) emissions. The higher the rating, the less impact it has on the environment.

Your current rating is **band F (30)**. The average rating for EPCs in Scotland is **band D (59)**.

The potential rating shows the effect of undertaking all of the improvement measures listed within your recommendations report.
