Home Report

Scottish Single Survey

Property address	12 Birkdale Park Armadale Bathgate EH48 2NE
-------------------------	--

Date of inspection	25/10/2023
---------------------------	------------

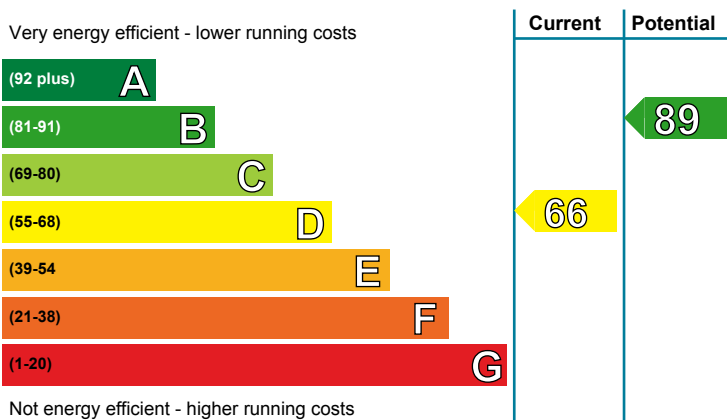
Energy Efficiency Rating

This graph shows the current efficiency of your home, taking into account both energy efficiency and fuel costs. The higher this rating, the lower your fuel bills are likely to be.

Your current rating is **band D (66)**. The average rating for EPCs in Scotland is **band D (61)**.

The potential rating shows the effect of undertaking all of the improvement measures listed within your recommendations report.

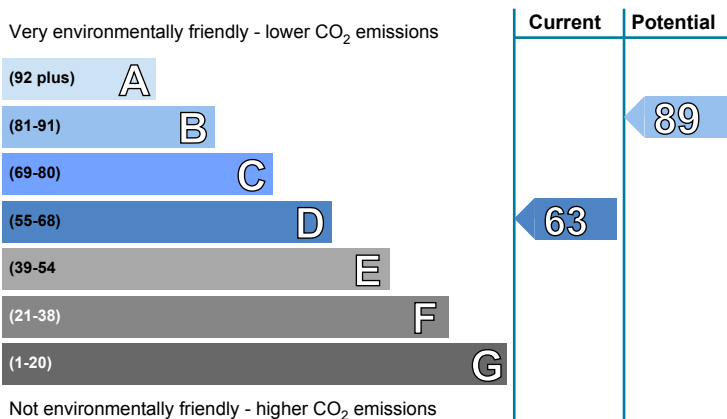
Environmental Impact (CO₂) Rating

This graph shows the effect of your home on the environment in terms of carbon dioxide (CO₂) emissions. The higher the rating, the less impact it has on the environment.
