HOME REPORT

13 Distillery Houses
Caol Ila
Isle of Islay
PA46 7RJ

Single Survey

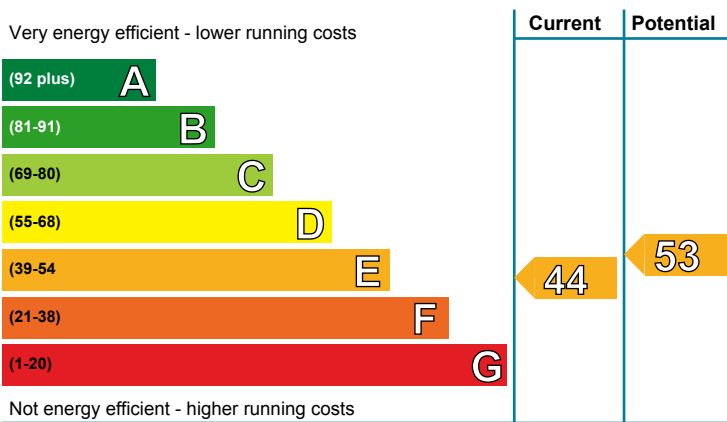
Energy Efficiency Rating

This graph shows the current efficiency of your home, taking into account both energy efficiency and fuel costs. The higher this rating, the lower your fuel bills are likely to be.

Your current rating is **band E (44)**. The average rating for EPCs in Scotland is **band D (61)**.

The potential rating shows the effect of undertaking all of the improvement measures listed within your recommendations report.

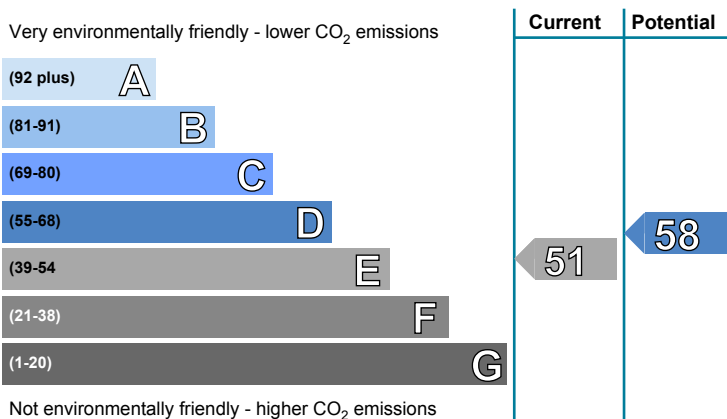
Environmental Impact (CO₂) Rating

This graph shows the effect of your home on the environment in terms of carbon dioxide (CO₂) emissions. The higher the rating, the less impact it has on the environment.

Your current rating is **band E (51)**. The average rating for EPCs in Scotland is **band D (59)**.

The potential rating shows the effect of undertaking all of the improvement measures listed within your recommendations report.
