Home Report

Scottish Single Survey

Property address	158 Elizabeth Drive Bathgate EH48 1HX
Customer	Mrs Petula Singleton
Customer address	158 Elizabeth Drive Bathgate EH48 1HX
Prepared by	Shepherd Chartered Surveyors
Date of inspection	18/12/2023

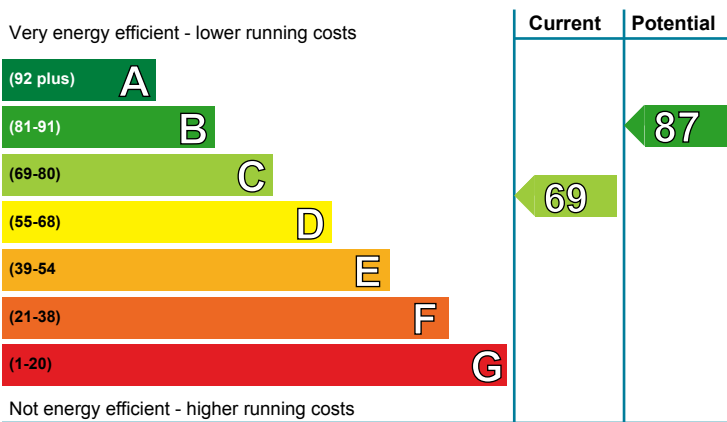
Energy Efficiency Rating

This graph shows the current efficiency of your home, taking into account both energy efficiency and fuel costs. The higher this rating, the lower your fuel bills are likely to be.

Your current rating is **band C (69)**. The average rating for EPCs in Scotland is **band D (61)**.

The potential rating shows the effect of undertaking all of the improvement measures listed within your recommendations report.
