Home Report

Scottish Single Survey

Property address	4 Lindsay Gardens Bathgate EH48 1DU
-------------------------	---

Prepared by	Shepherd Chartered Surveyors
--------------------	------------------------------

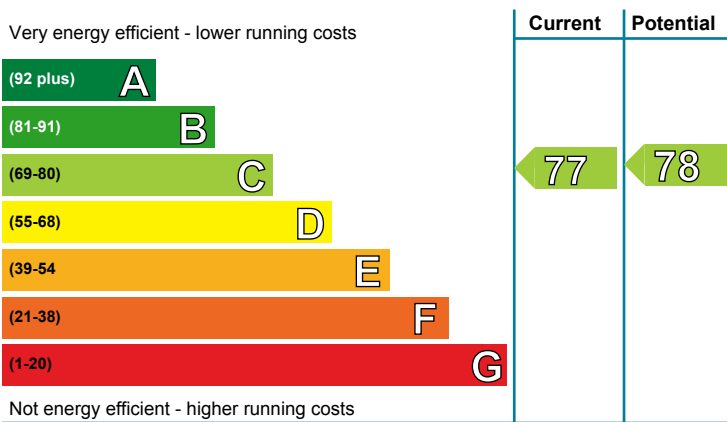
Energy Efficiency Rating

This graph shows the current efficiency of your home, taking into account both energy efficiency and fuel costs. The higher this rating, the lower your fuel bills are likely to be.

Your current rating is **band C (77)**. The average rating for EPCs in Scotland is **band D (61)**.

The potential rating shows the effect of undertaking all of the improvement measures listed within your recommendations report.
