HOME REPORT

THE BUNGALOW BALLYGRANT

ISLE OF ISLAY
PA45 7QR

Single Survey

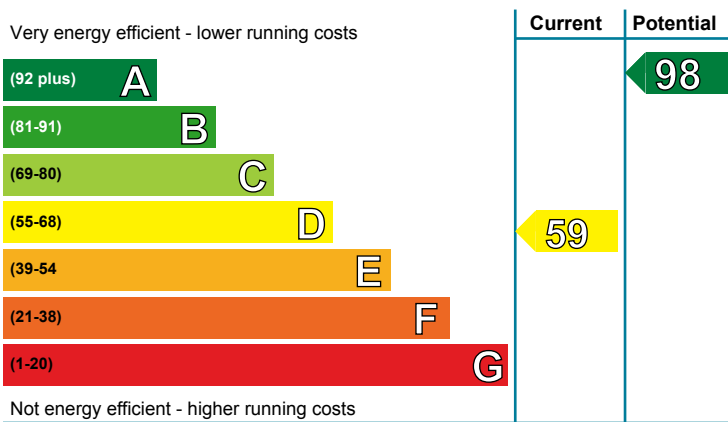
Energy Efficiency Rating

This graph shows the current efficiency of your home, taking into account both energy efficiency and fuel costs. The higher this rating, the lower your fuel bills are likely to be.

Your current rating is **band D (59)**. The average rating for EPCs in Scotland is **band D (61)**.

The potential rating shows the effect of undertaking all of the improvement measures listed within your recommendations report.
