HOME REPORT

46D Brodie Crescent
Lochgilphead
PA31 8NW

Energy Performance Certificate (EPC)

Single Survey

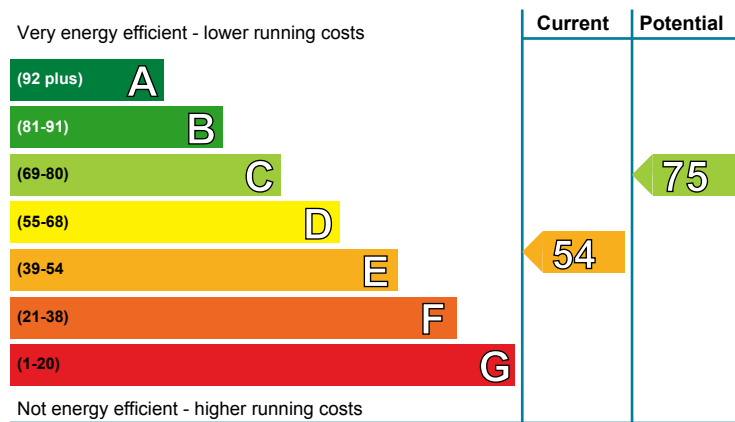
Energy Efficiency Rating

This graph shows the current efficiency of your home, taking into account both energy efficiency and fuel costs. The higher this rating, the lower your fuel bills are likely to be.

Your current rating is **band E (54)**. The average rating for EPCs in Scotland is **band D (61)**.

The potential rating shows the effect of undertaking all of the improvement measures listed within your recommendations report.

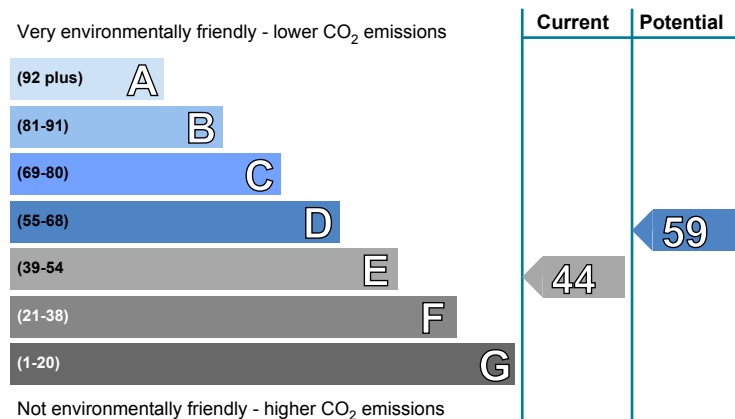
Environmental Impact (CO₂) Rating

This graph shows the effect of your home on the environment in terms of carbon dioxide (CO₂) emissions. The higher the rating, the less impact it has on the environment.

Your current rating is **band E (44)**. The average rating for EPCs in Scotland is **band D (59)**.

The potential rating shows the effect of undertaking all of the improvement measures listed within your recommendations report.

The average Scottish household produces about 6 tonnes of carbon dioxide every year. Based on this assessment, heating and lighting this home currently produces approximately 4.2 tonnes of carbon dioxide every year. Adopting recommendations in this report can reduce emissions and protect the environment. If you were to install all of these recommendations this could reduce emissions by 1.3 tonnes per year. You could reduce emissions even more by switching to renewable energy sources.
