Home Report

Scottish Single Survey

Property address	Flat 6 Townhead Apartments Alloa FK10 1LF
-------------------------	--

Prepared by	Shepherd Chartered Surveyors
--------------------	------------------------------

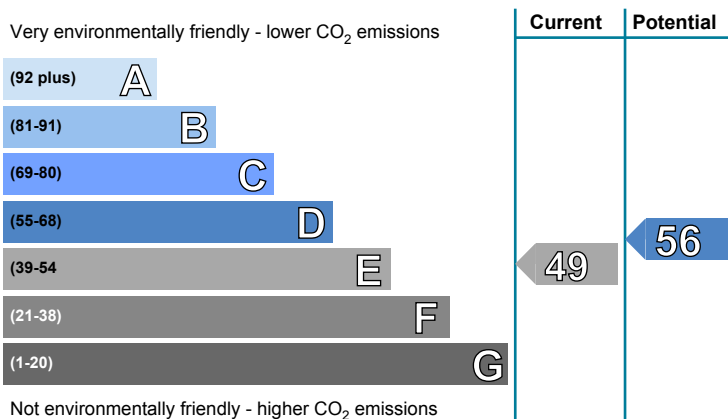
Environmental Impact (CO₂) Rating

This graph shows the effect of your home on the environment in terms of carbon dioxide (CO₂) emissions. The higher the rating, the less impact it has on the environment.
