Home Report

Scottish Single Survey

Property address	15 Quebec Avenue Livingston EH54 6BT
Customer	Leanne Shaw
Customer address	15 Quebec Avenue Livingston EH54 6BT
Prepared by	Shepherd Chartered Surveyors
Date of inspection	18/03/2024

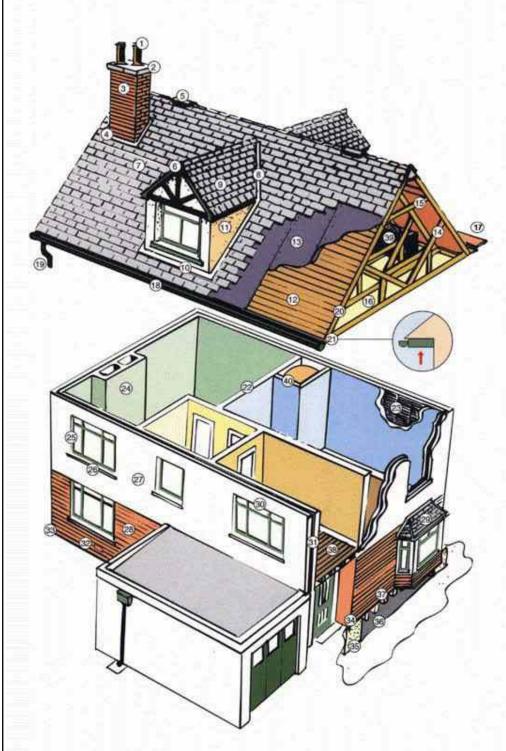
Sectional Diagram showing elements of a typical house

Reference may be made in this report to some or all of the above component parts of the property. This diagram may assist you in locating and understanding these items.

- 1) Chimney pots
- 2) Coping stone
- 3 Chimney head
- (4) Flashing
- 5) Ridge ventilation
- 6 Ridge board
- 7 Slates / tiles
- 8 Valley guttering
- Dormer projection
- 10) Dormer flashing
- 11) Dormer cheeks
- (12) Sarking
- 13) Roof felt
- 14) Trusses
- (15) Collar
- 16) Insulation
- (17) Parapet gutter
- 18) Eaves guttering
- (19) Rainwater downpipe
- 20) Verge boards/skews
- 21) Soffit boards
- 22) Partition wall
- 23) Lath / plaster
- (24) Chimney breast
- 25) Window pointing
- 26) Window sills
- 27) Rendering
- (28) Brickwork / pointing
- 29) Bay window projection
- (30) Lintels
- (31) Cavity walls / wall ties
- 32) Subfloor ventilator
- (33) Damp proof course
- 34) Base course
- 35) Foundations
- 36) Solum
- Floor joists
- 38) Floorboards
- 39) Water tank
- 40) Hot water tank
