HOME REPORT

LINTHOUSE BARMORE ROAD

TARBERT
PA29 6TW

Energy Performance Certificate (EPC)

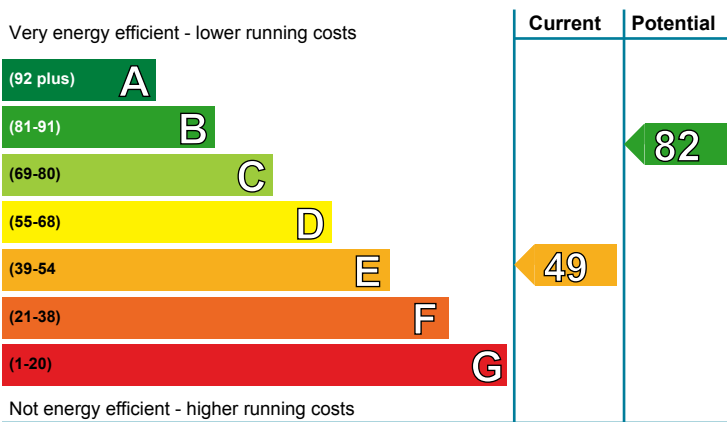
Energy Efficiency Rating

This graph shows the current efficiency of your home, taking into account both energy efficiency and fuel costs. The higher this rating, the lower your fuel bills are likely to be.

Your current rating is **band E (49)**. The average rating for EPCs in Scotland is **band D (61)**.

The potential rating shows the effect of undertaking all of the improvement measures listed within your recommendations report.

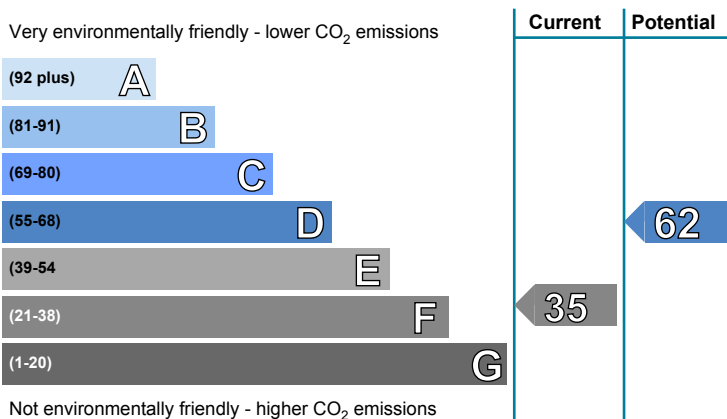
Environmental Impact (CO₂) Rating

This graph shows the effect of your home on the environment in terms of carbon dioxide (CO₂) emissions. The higher the rating, the less impact it has on the environment.

Your current rating is **band F (35)**. The average rating for EPCs in Scotland is **band D (59)**.

The potential rating shows the effect of undertaking all of the improvement measures listed within your recommendations report.
