HOME REPORT

38A LOCHNELL STREET
LOCHGILPHEAD
PA31 8JN

38A LOCHNELL STREET, LOCHGILPHEAD, PA31 8JN

Dwelling type: Ground-floor flat
Date of assessment: 17 April 2024
Date of certificate: 18 April 2024
Total floor area: 42 m²
Primary Energy Indicator: 645 kWh/m²/year

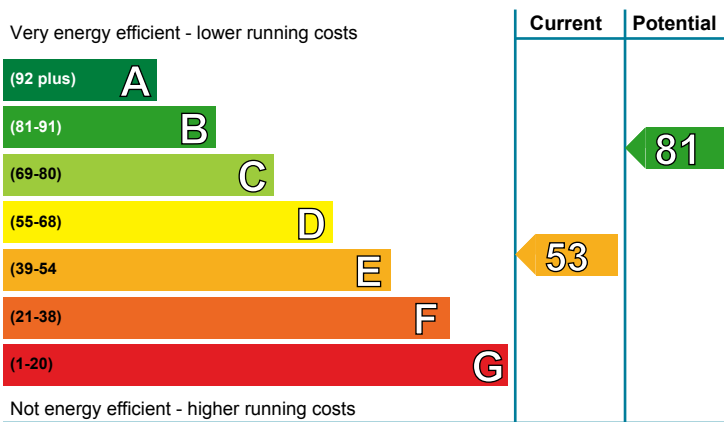
Energy Efficiency Rating

This graph shows the current efficiency of your home, taking into account both energy efficiency and fuel costs. The higher this rating, the lower your fuel bills are likely to be.

Your current rating is **band E (53)**. The average rating for EPCs in Scotland is **band D (61)**.

The potential rating shows the effect of undertaking all of the improvement measures listed within your recommendations report.

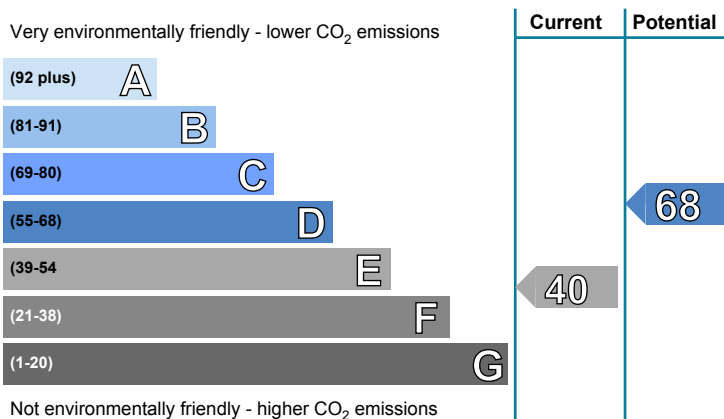
Environmental Impact (CO₂) Rating

This graph shows the effect of your home on the environment in terms of carbon dioxide (CO₂) emissions. The higher the rating, the less impact it has on the environment.

Your current rating is **band E (40)**. The average rating for EPCs in Scotland is **band D (59)**.

The potential rating shows the effect of undertaking all of the improvement measures listed within your recommendations report.
