HOME REPORT

Inn Cottage

**Achahoish
PA31 8PA**

Energy Performance Certificate (EPC)

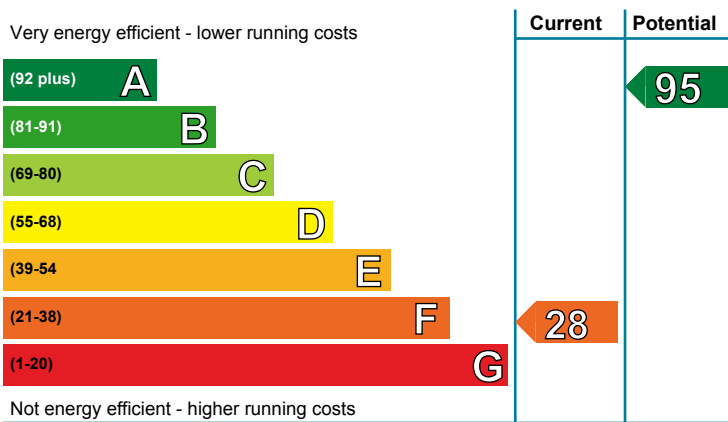
Energy Efficiency Rating

This graph shows the current efficiency of your home, taking into account both energy efficiency and fuel costs. The higher this rating, the lower your fuel bills are likely to be.

Your current rating is **band F (28)**. The average rating for EPCs in Scotland is **band D (61)**.

The potential rating shows the effect of undertaking all of the improvement measures listed within your recommendations report.

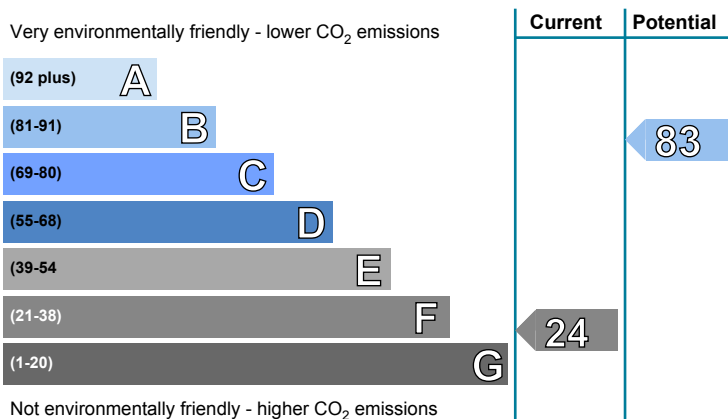
Environmental Impact (CO₂) Rating

This graph shows the effect of your home on the environment in terms of carbon dioxide (CO₂) emissions. The higher the rating, the less impact it has on the environment.

Your current rating is **band F (24)**. The average rating for EPCs in Scotland is **band D (59)**.

The potential rating shows the effect of undertaking all of the improvement measures listed within your recommendations report.
