HOME REPORT

Flat 4
65 Chalmers Street
Adrishalg
Lochgillthead
PA30 8DX

Energy Performance Certificate (EPC)

Flat 4 , 65 Chalmers Street, Adrishaig, Lochgilphead, PA30 8DX

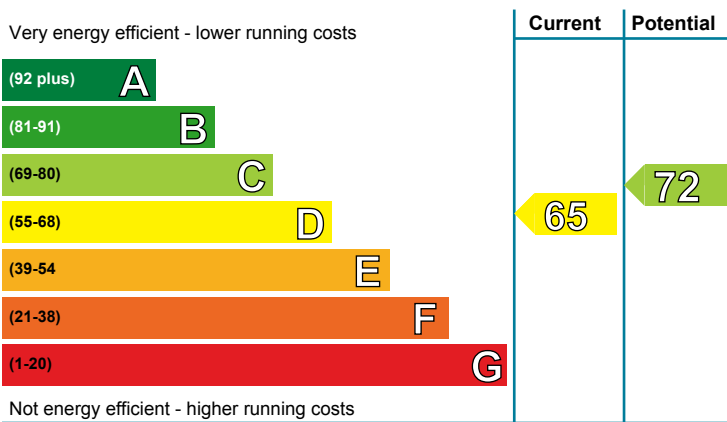
Energy Efficiency Rating

This graph shows the current efficiency of your home, taking into account both energy efficiency and fuel costs. The higher this rating, the lower your fuel bills are likely to be.

Your current rating is **band D (65)**. The average rating for EPCs in Scotland is **band D (61)**.

The potential rating shows the effect of undertaking all of the improvement measures listed within your recommendations report.
