# HOME REPORT

TAYNESS  
2 KILMARTIN  
LOCHGILPHEAD  
PA31 8QF

# Energy Performance Certificate (EPC)

**TAYNESS, 2, KILMARTIN, LOCHGILPHEAD, PA31 8QF**

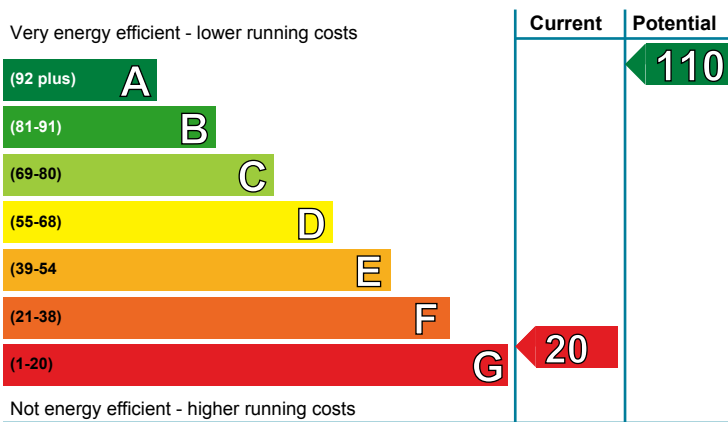
## Energy Efficiency Rating

This graph shows the current efficiency of your home, taking into account both energy efficiency and fuel costs. The higher this rating, the lower your fuel bills are likely to be.

Your current rating is **band G (20)**. The average rating for EPCs in Scotland is **band D (61)**.

The potential rating shows the effect of undertaking all of the improvement measures listed within your recommendations report.

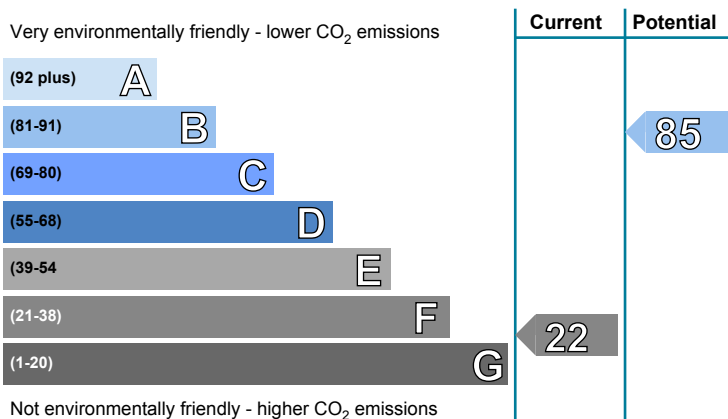
## Environmental Impact (CO<sub>2</sub>) Rating

This graph shows the effect of your home on the environment in terms of carbon dioxide (CO<sub>2</sub>) emissions. The higher the rating, the less impact it has on the environment.

Your current rating is **band F (22)**. The average rating for EPCs in Scotland is **band D (59)**.

The potential rating shows the effect of undertaking all of the improvement measures listed within your recommendations report.
