HOME REPORT

Furrows End Conisby

ENERGY PERFORMANCE CERTIFICATE

SINGLE SURVEY

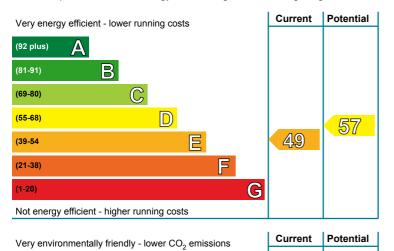
Energy Efficiency Rating

This graph shows the current efficiency of your home, taking into account both energy efficiency and fuel costs. The higher this rating, the lower your fuel bills are likely to be.

The potential rating shows the effect of undertaking all of the improvement measures listed within your recommendations report.
