HOME REPORT

30 HUDDERSFIELD STREET
GALASHIELS
TD1 3AX

Energy Performance Certificate (EPC)

30 HUDDERSFIELD STREET, GALASHIELS, TD1 3AX

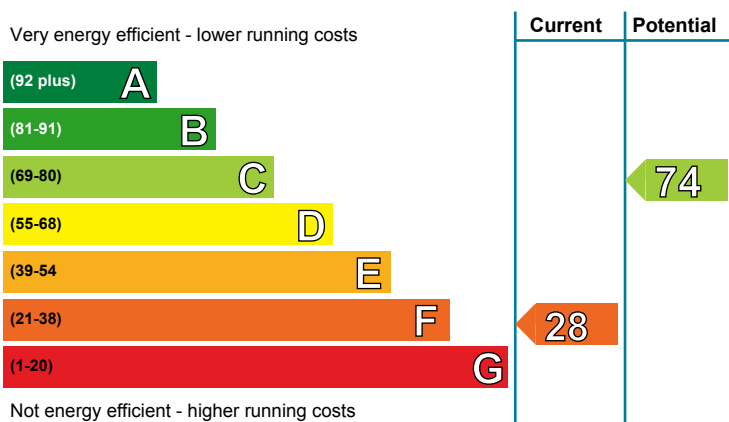
Energy Efficiency Rating

This graph shows the current efficiency of your home, taking into account both energy efficiency and fuel costs. The higher this rating, the lower your fuel bills are likely to be.

Your current rating is **band F (28)**. The average rating for EPCs in Scotland is **band D (61)**.

The potential rating shows the effect of undertaking all of the improvement measures listed within your recommendations report.

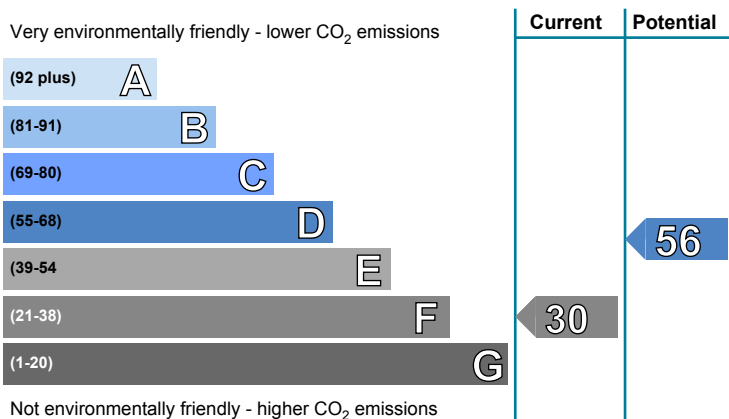
Environmental Impact (CO₂) Rating

This graph shows the effect of your home on the environment in terms of carbon dioxide (CO₂) emissions. The higher the rating, the less impact it has on the environment.

Your current rating is **band F (30)**. The average rating for EPCs in Scotland is **band D (59)**.

The potential rating shows the effect of undertaking all of the improvement measures listed within your recommendations report.
