YOUR ONESURVEY
HOME REPORT

9 Keills Cottages
Keills, Isle of Islay
PA46 7RG

SINGLE SURVEY

Surveyor Reference	HH/3726
Customer	Mrs. Dolinda Jamieson
Selling address	9 Keills Cottages Keills, Isle of Islay PA46 7RG
Date of Inspection	11/12/2024
Prepared by	Graeme Armour, BSc MRICs Helensburgh - Allied Surveyors Scotland Ltd

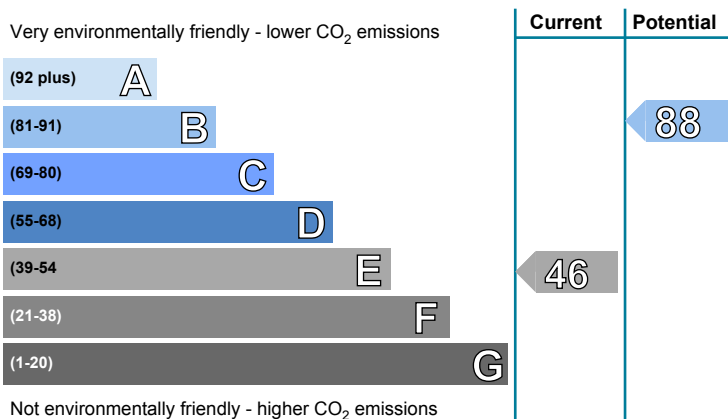
Environmental Impact (CO₂) Rating

This graph shows the effect of your home on the environment in terms of carbon dioxide (CO₂) emissions. The higher the rating, the less impact it has on the environment.
