HOME REPORT

Flat 3 45 Chalmers Street
ARDRISHAIG
PA30 8EY

Energy Performance Certificate (EPC)

Flat 3, 45 Chalmers Street, Ardrishaig, PA30 8EY

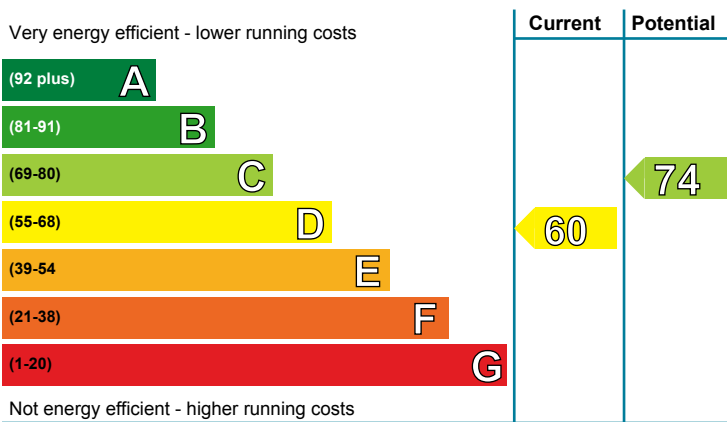
Energy Efficiency Rating

This graph shows the current efficiency of your home, taking into account both energy efficiency and fuel costs. The higher this rating, the lower your fuel bills are likely to be.

Your current rating is **band D (60)**. The average rating for EPCs in Scotland is **band D (61)**.

The potential rating shows the effect of undertaking all of the improvement measures listed within your recommendations report.
