# HOME REPORT

# Energy Performance Certificate (EPC)

FLAT 2/1 , 5 SANDYHILLS ROAD, GLASGOW, G32 0QG

# SINGLE SURVEY

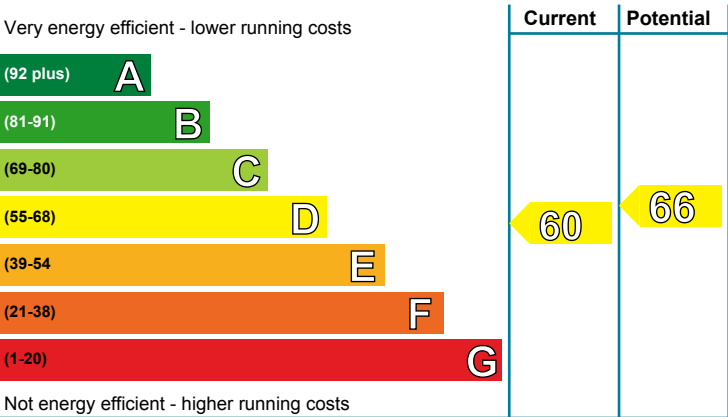
### Energy Efficiency Rating

This graph shows the current efficiency of your home, taking into account both energy efficiency and fuel costs. The higher this rating, the lower your fuel bills are likely to be.

Your current rating is **band D (60)**. The average rating for EPCs in Scotland is **band D (61)**.

The potential rating shows the effect of undertaking all of the improvement measures listed within your recommendations report.

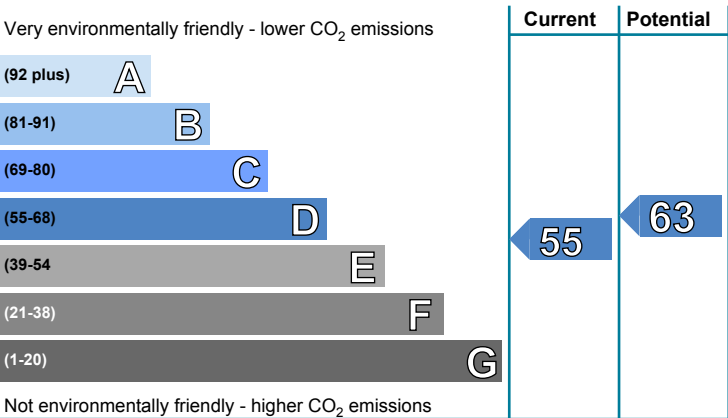
### Environmental Impact (CO<sub>2</sub>) Rating

This graph shows the effect of your home on the environment in terms of carbon dioxide (CO<sub>2</sub>) emissions. The higher the rating, the less impact it has on the environment.

Your current rating is **band D (55)**. The average rating for EPCs in Scotland is **band D (59)**.

The potential rating shows the effect of undertaking all of the improvement measures listed within your recommendations report.
