Home Report

Scottish Single Survey

Property address	47 School Street Fraserburgh AB43 9HT
Customer	Mr. Paul Burnett
Customer address	47 School Street Fraserburgh AB43 9HT
Prepared by	Shepherd Chartered Surveyors
Date of inspection	24/05/2024

**Energy
Performance
Certificate**

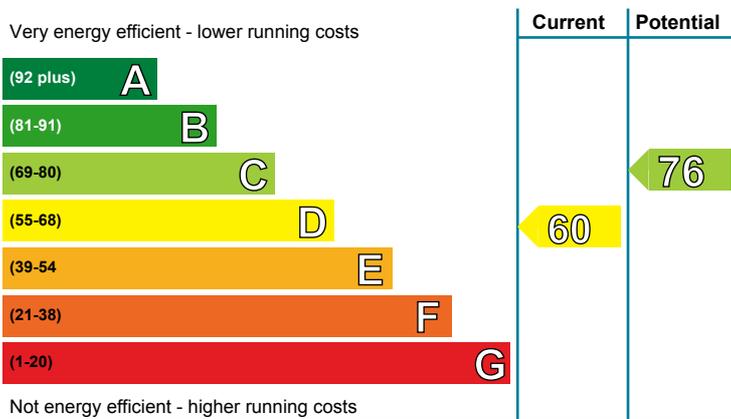
Energy Efficiency Rating

This graph shows the current efficiency of your home, taking into account both energy efficiency and fuel costs. The higher this rating, the lower your fuel bills are likely to be.

Your current rating is **band D (60)**. The average rating for EPCs in Scotland is **band D (61)**.

The potential rating shows the effect of undertaking all of the improvement measures listed within your recommendations report.
