epoch home report

Burnbrae
Redgate Hill
Kippen
Stirling
FK8 3HS
10/11/2025

Home Report Index

HOME REPORT

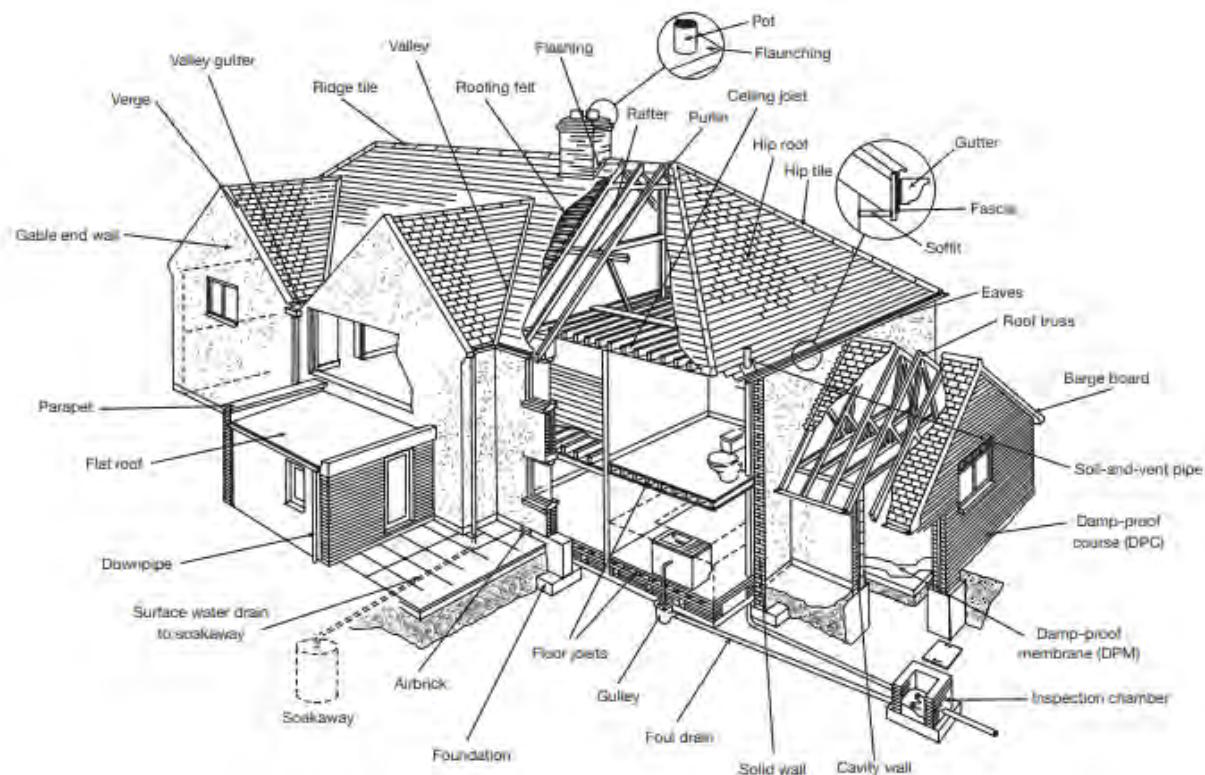
Sectional diagram showing elements of a typical house

Reference may be made in this report to some or all of the above building elements of the property.

This diagram may assist you in locating and understanding these terms.

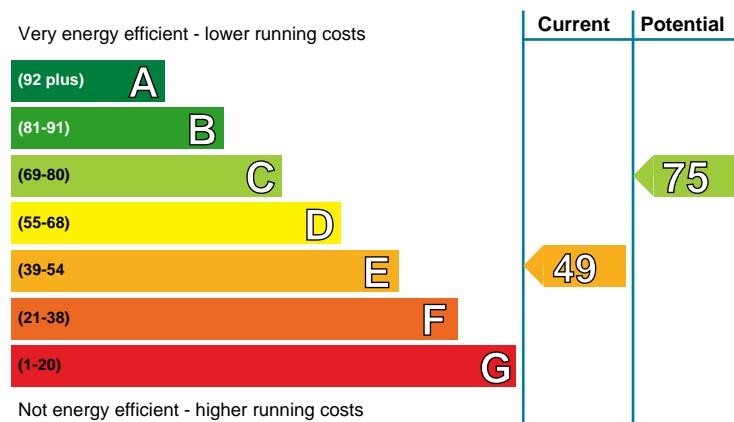
Energy Efficiency Rating

This graph shows the current efficiency of your home, taking into account both energy efficiency and fuel costs. The higher this rating, the lower your fuel bills are likely to be.

Your current rating is **band E (49)**. The average rating for EPCs in Scotland is **band D (61)**.

The potential rating shows the effect of undertaking all of the improvement measures listed within your recommendations report.

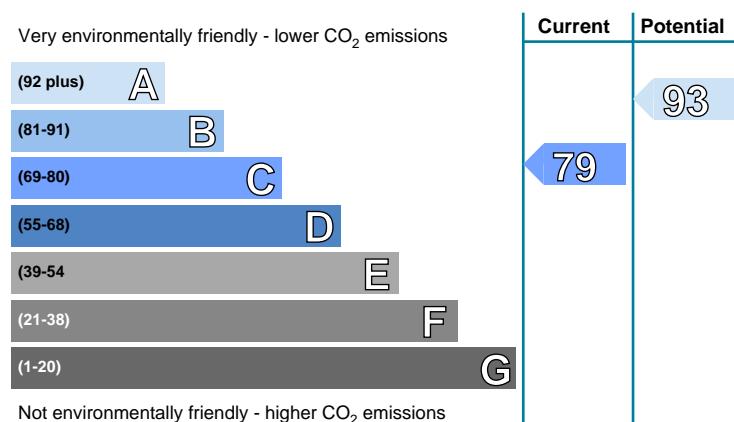
Environmental Impact (CO₂) Rating

This graph shows the effect of your home on the environment in terms of carbon dioxide (CO₂) emissions. The higher the rating, the less impact it has on the environment.
