Single Survey

survey report on:

Property address	7 Union Street Rosehearty Fraserburgh AB43 7JQ
Customer	Exc of the Late Mrs N Strachan
Customer address	7 Union Street Rosehearty Fraserburgh AB43 7JQ
Prepared by	Shepherd Chartered Surveyors
Date of inspection	31/07/2023

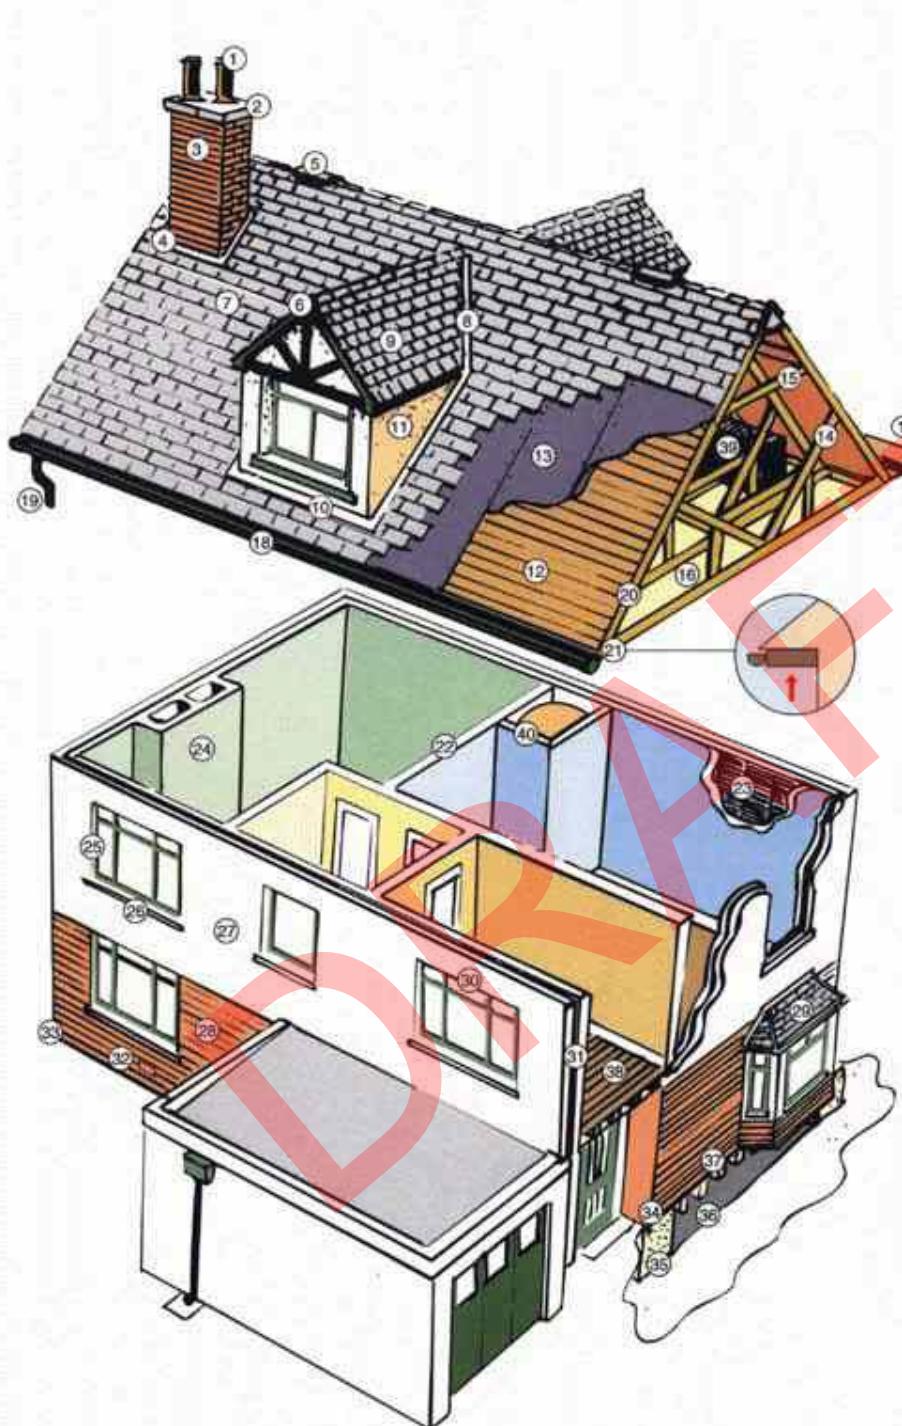
Sectional Diagram showing elements of a typical house

- 1 Chimney pots
- 2 Coping stone
- 3 Chimney head
- 4 Flashing
- 5 Ridge ventilation
- 6 Ridge board
- 7 Slates / tiles
- 8 Valley guttering
- 9 Dormer projection
- 10 Dormer flashing
- 11 Dormer cheeks
- 12 Sarking
- 13 Roof felt
- 14 Trusses
- 15 Collar
- 16 Insulation
- 17 Parapet gutter
- 18 Eaves guttering
- 19 Rainwater downpipe
- 20 Verge boards /skews
- 21 Soffit boards
- 22 Partition wall
- 23 Lath / plaster
- 24 Chimney breast
- 25 Window pointing
- 26 Window sills
- 27 Rendering
- 28 Brickwork / pointing
- 29 Bay window projection
- 30 Lintels
- 31 Cavity walls / wall ties
- 32 Subfloor ventilator
- 33 Damp proof course
- 34 Base course
- 35 Foundations
- 36 Solum
- 37 Floor joists
- 38 Floorboards
- 39 Water tank
- 40 Hot water tank

Reference may be made in this report to some or all of the above component parts of the property. This diagram may assist you in locating and understanding these items.
