Home Report

Single Survey

Property address	Brae House, 7 Ardcharnich Lochbroom, Garve, IV23 2RQ IV23 2RQ
Customer	Clair Williams & Darren Wilson
Customer address	Brae House, 7 Ardcharnich Lochbroom, Garve, IV23 2RQ IV23 2RQ
Prepared by	Shepherd Chartered Surveyors
Date of inspection	23/01/2026

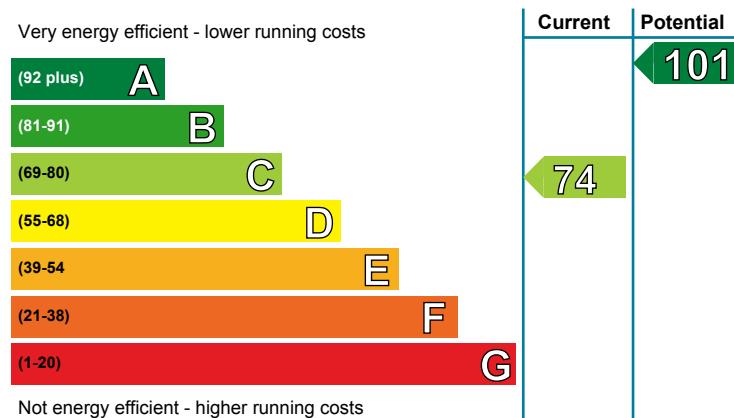
Energy Efficiency Rating

This graph shows the current efficiency of your home, taking into account both energy efficiency and fuel costs. The higher this rating, the lower your fuel bills are likely to be.

Your current rating is **band C (74)**. The average rating for EPCs in Scotland is **band D (61)**.

The potential rating shows the effect of undertaking all of the improvement measures listed within your recommendations report.

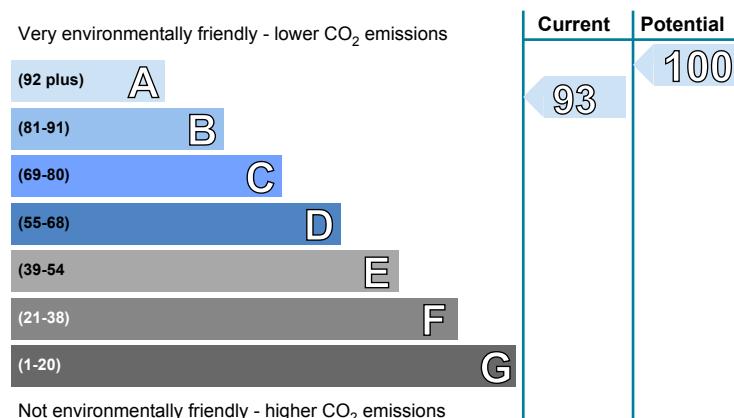
Environmental Impact (CO₂) Rating

This graph shows the effect of your home on the environment in terms of carbon dioxide (CO₂) emissions. The higher the rating, the less impact it has on the environment.
