Home Report

Single Survey

6a Allan Park,
Stirling,
Stirlingshire,
FK8 2QG

SINGLE SURVEY TERMS AND CONDITIONS (WITH MVR)

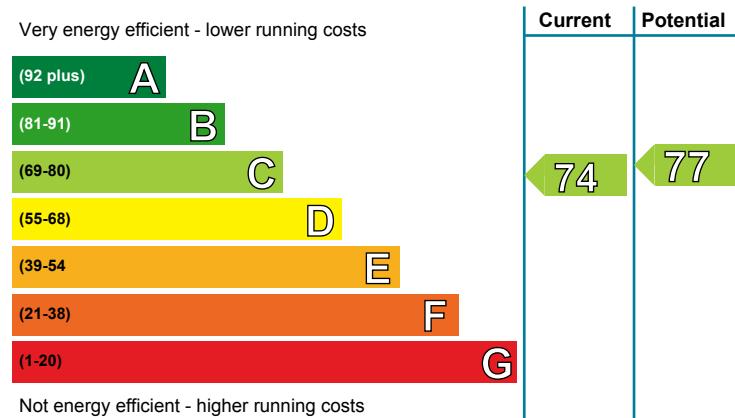
Energy Efficiency Rating

This graph shows the current efficiency of your home, taking into account both energy efficiency and fuel costs. The higher this rating, the lower your fuel bills are likely to be.

Your current rating is **band C (74)**. The average rating for EPCs in Scotland is **band D (61)**.

The potential rating shows the effect of undertaking all of the improvement measures listed within your recommendations report.

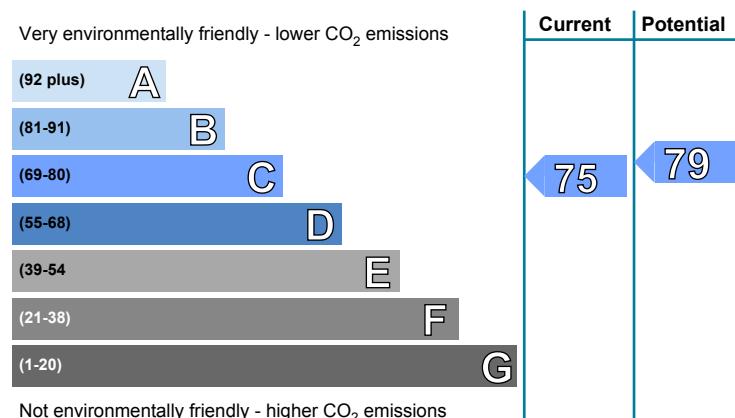
Environmental Impact (CO₂) Rating

This graph shows the effect of your home on the environment in terms of carbon dioxide (CO₂) emissions. The higher the rating, the less impact it has on the environment.
