Home Report

21 Osprey Drive
Kilmarnock KA1 3LQ

Single Survey

Property Address	21 Osprey Drive Kilmarnock KA1 3LQ
Customer	Mr James Drennan
Prepared by	Graham + Sibbald Property Consultants Limited
Date of Inspection	19/02/2026

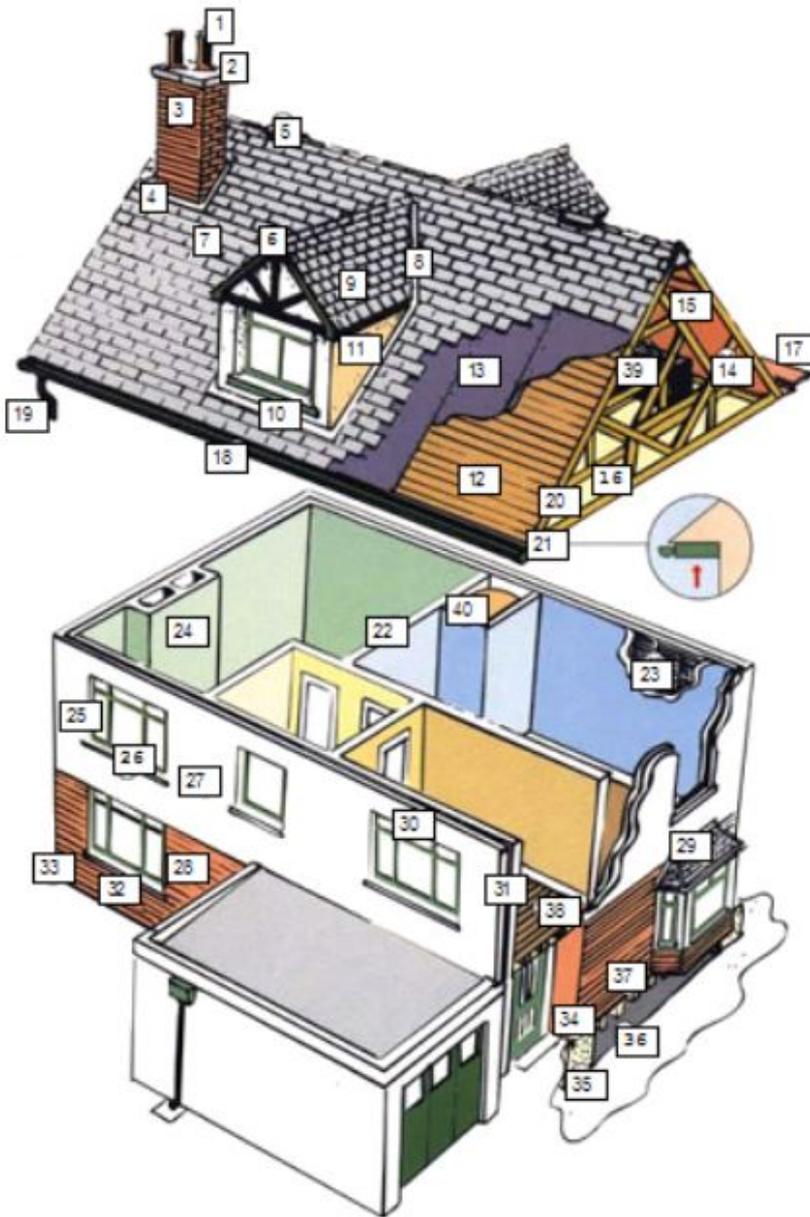
Sectional diagram showing elements of a typical house

1	Chimney pots
2	Coping stone
3	Chimney head
4	Flashing
5	Ridge ventilation
6	Ridge board
7	Slates / tiles
8	Valley guttering
9	Dormer projection
10	Dormer flashing
11	Dormer cheeks
12	Sarking
13	Roof felt
14	Trusses
15	Collar
16	Insulation
17	Parapet gutter
18	Eaves guttering
19	Rainwater downpipe
20	Verge boards / skews
21	Soffit boards
22	Partition wall
23	Lath / plaster
24	Chimney breast
25	Window pointing
26	Window sills
27	Rendering
28	Brickwork / pointing
29	Bay window projection
30	Lintels
31	Cavity walls / wall ties
32	Subfloor ventilator
33	Damp proof course
34	Base course
35	Foundations
36	Solum
37	Floor joists
38	Floorboards
39	Water tank
40	Hot water tank

Reference may be made in this report to some or all of the above component parts of the property. This diagram may assist you in locating and understanding these items.
