Home Report

Scottish Single Survey

Property address	58 Gilmerton Dykes Street Edinburgh EH17 8LH
-------------------------	--

Prepared by	Shepherd Chartered Surveyors
--------------------	------------------------------

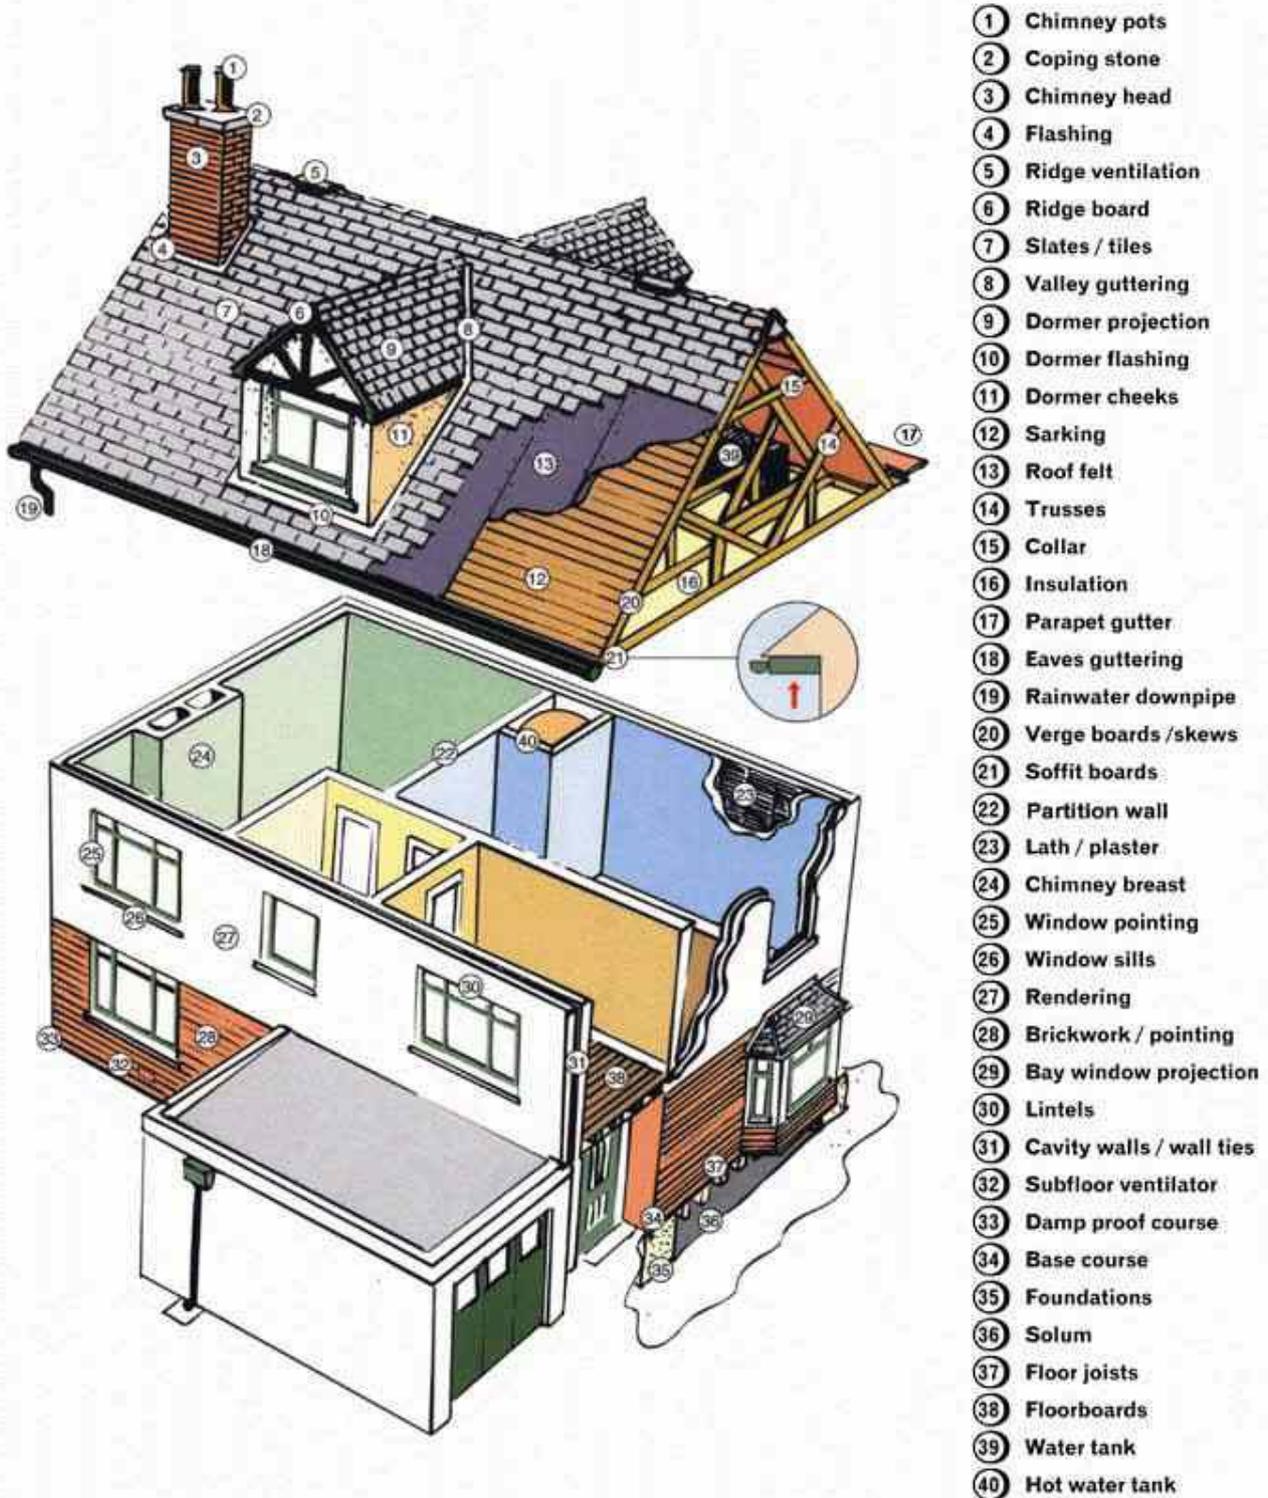
Sectional Diagram showing elements of a typical house

Reference may be made in this report to some or all of the above component parts of the property. This diagram may assist you in locating and understanding these items.

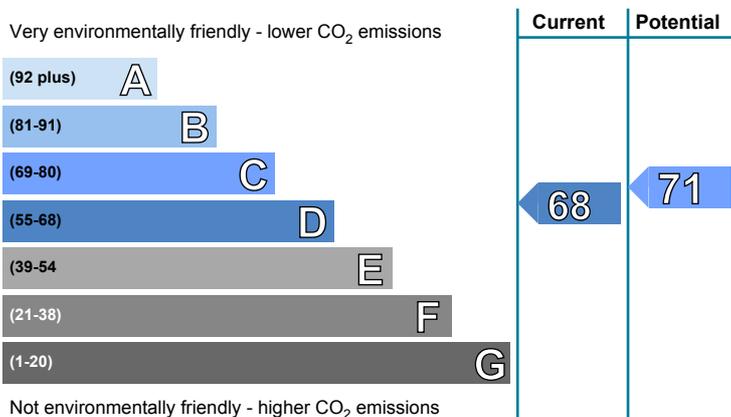
Environmental Impact (CO₂) Rating

This graph shows the effect of your home on the environment in terms of carbon dioxide (CO₂) emissions. The higher the rating, the less impact it has on the environment.
