YOUR ONESURVEY  
**HOME REPORT**

Brambles  
Upper Torwoodhill Road  
Rhu  
Helensburgh, G84 8LE

# SINGLE SURVEY

A report on the condition of the property, with categories being rated from 1 to 3.

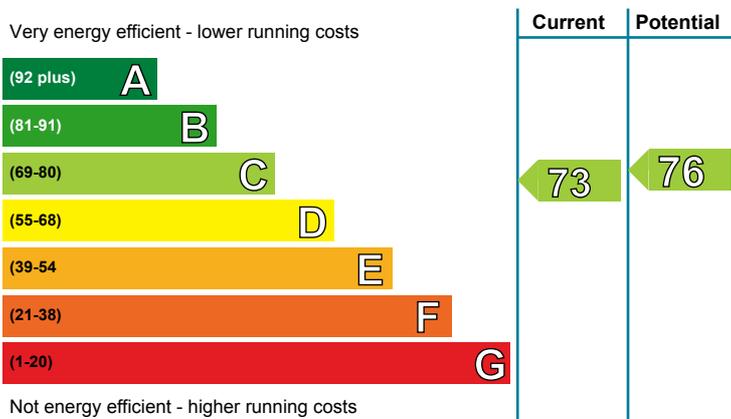
## Energy Efficiency Rating

This graph shows the current efficiency of your home, taking into account both energy efficiency and fuel costs. The higher this rating, the lower your fuel bills are likely to be.

Your current rating is **band C (73)**. The average rating for EPCs in Scotland is **band D (61)**.

The potential rating shows the effect of undertaking all of the improvement measures listed within your recommendations report.

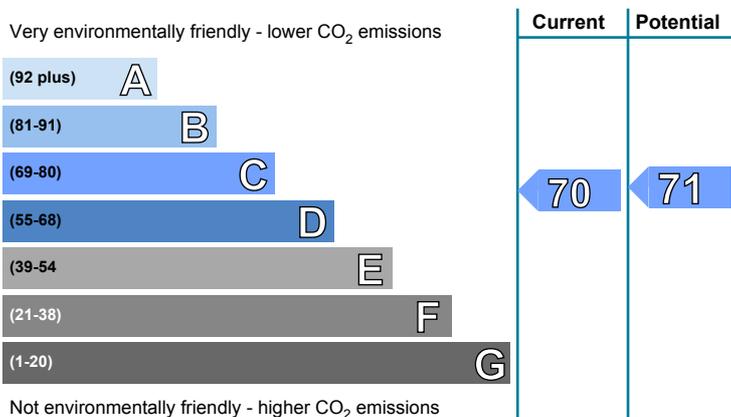
## Environmental Impact (CO<sub>2</sub>) Rating

This graph shows the effect of your home on the environment in terms of carbon dioxide (CO<sub>2</sub>) emissions. The higher the rating, the less impact it has on the environment.
