# Home Report

# Scottish Single Survey

<b>Property address</b>	13 Forth Street Cambus Alloa FK10 2NU
-------------------------	--

<b>Prepared by</b>	Shepherd Chartered Surveyors
--------------------	------------------------------

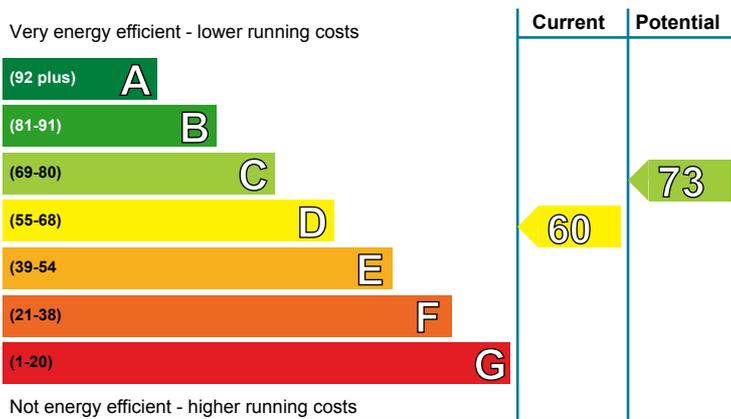
## Energy Efficiency Rating

This graph shows the current efficiency of your home, taking into account both energy efficiency and fuel costs. The higher this rating, the lower your fuel bills are likely to be.

Your current rating is **band D (60)**. The average rating for EPCs in Scotland is **band D (61)**.

The potential rating shows the effect of undertaking all of the improvement measures listed within your recommendations report.

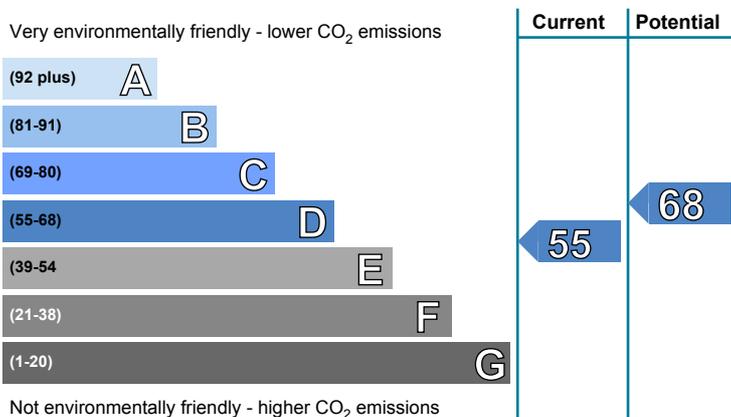
## Environmental Impact (CO<sub>2</sub>) Rating

This graph shows the effect of your home on the environment in terms of carbon dioxide (CO<sub>2</sub>) emissions. The higher the rating, the less impact it has on the environment.
