Home Report

Scottish Single Survey

Property address	Lynwood Castle Fraser Inverurie AB51 7JR
Customer	Mr George Smith
Customer address	Lynwood Castle Fraser Inverurie AB51 7JR
Prepared by	Shepherd Chartered Surveyors
Date of inspection	05/03/2026

**Energy
Performance
Certificate**

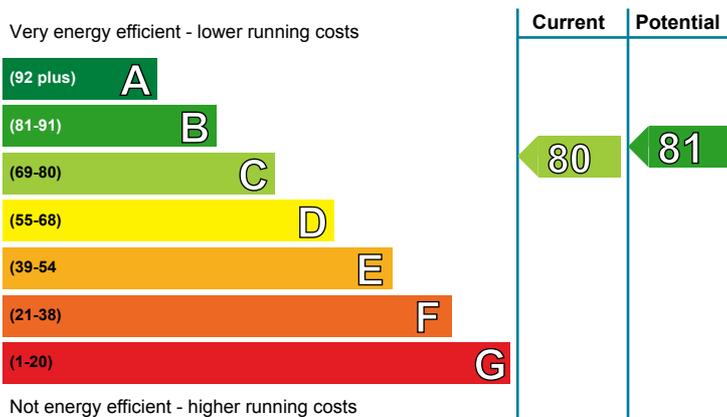
Energy Efficiency Rating

This graph shows the current efficiency of your home, taking into account both energy efficiency and fuel costs. The higher this rating, the lower your fuel bills are likely to be.

Your current rating is **band C (80)**. The average rating for EPCs in Scotland is **band D (61)**.

The potential rating shows the effect of undertaking all of the improvement measures listed within your recommendations report.

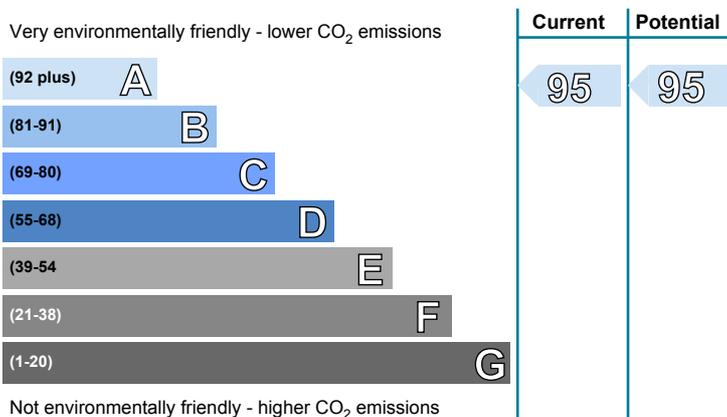
Environmental Impact (CO₂) Rating

This graph shows the effect of your home on the environment in terms of carbon dioxide (CO₂) emissions. The higher the rating, the less impact it has on the environment.
